**APPENDIX 20**  
**STORM WATER RETENTION POND AND SOLAR EVAPORATION POND INSPECTION**  
**REPORTS**

**APPENDIX 20.1**  
**POND INSPECTION REPORTS**

RE: Storm Water Detention Pond Liner Specifications  
Exide Technologies  
7471 South Fifth Street  
Frisco, Texas  
TPDES Permit No. WQ0002964000 (TX0103292)  
W&M Project No. 112.034

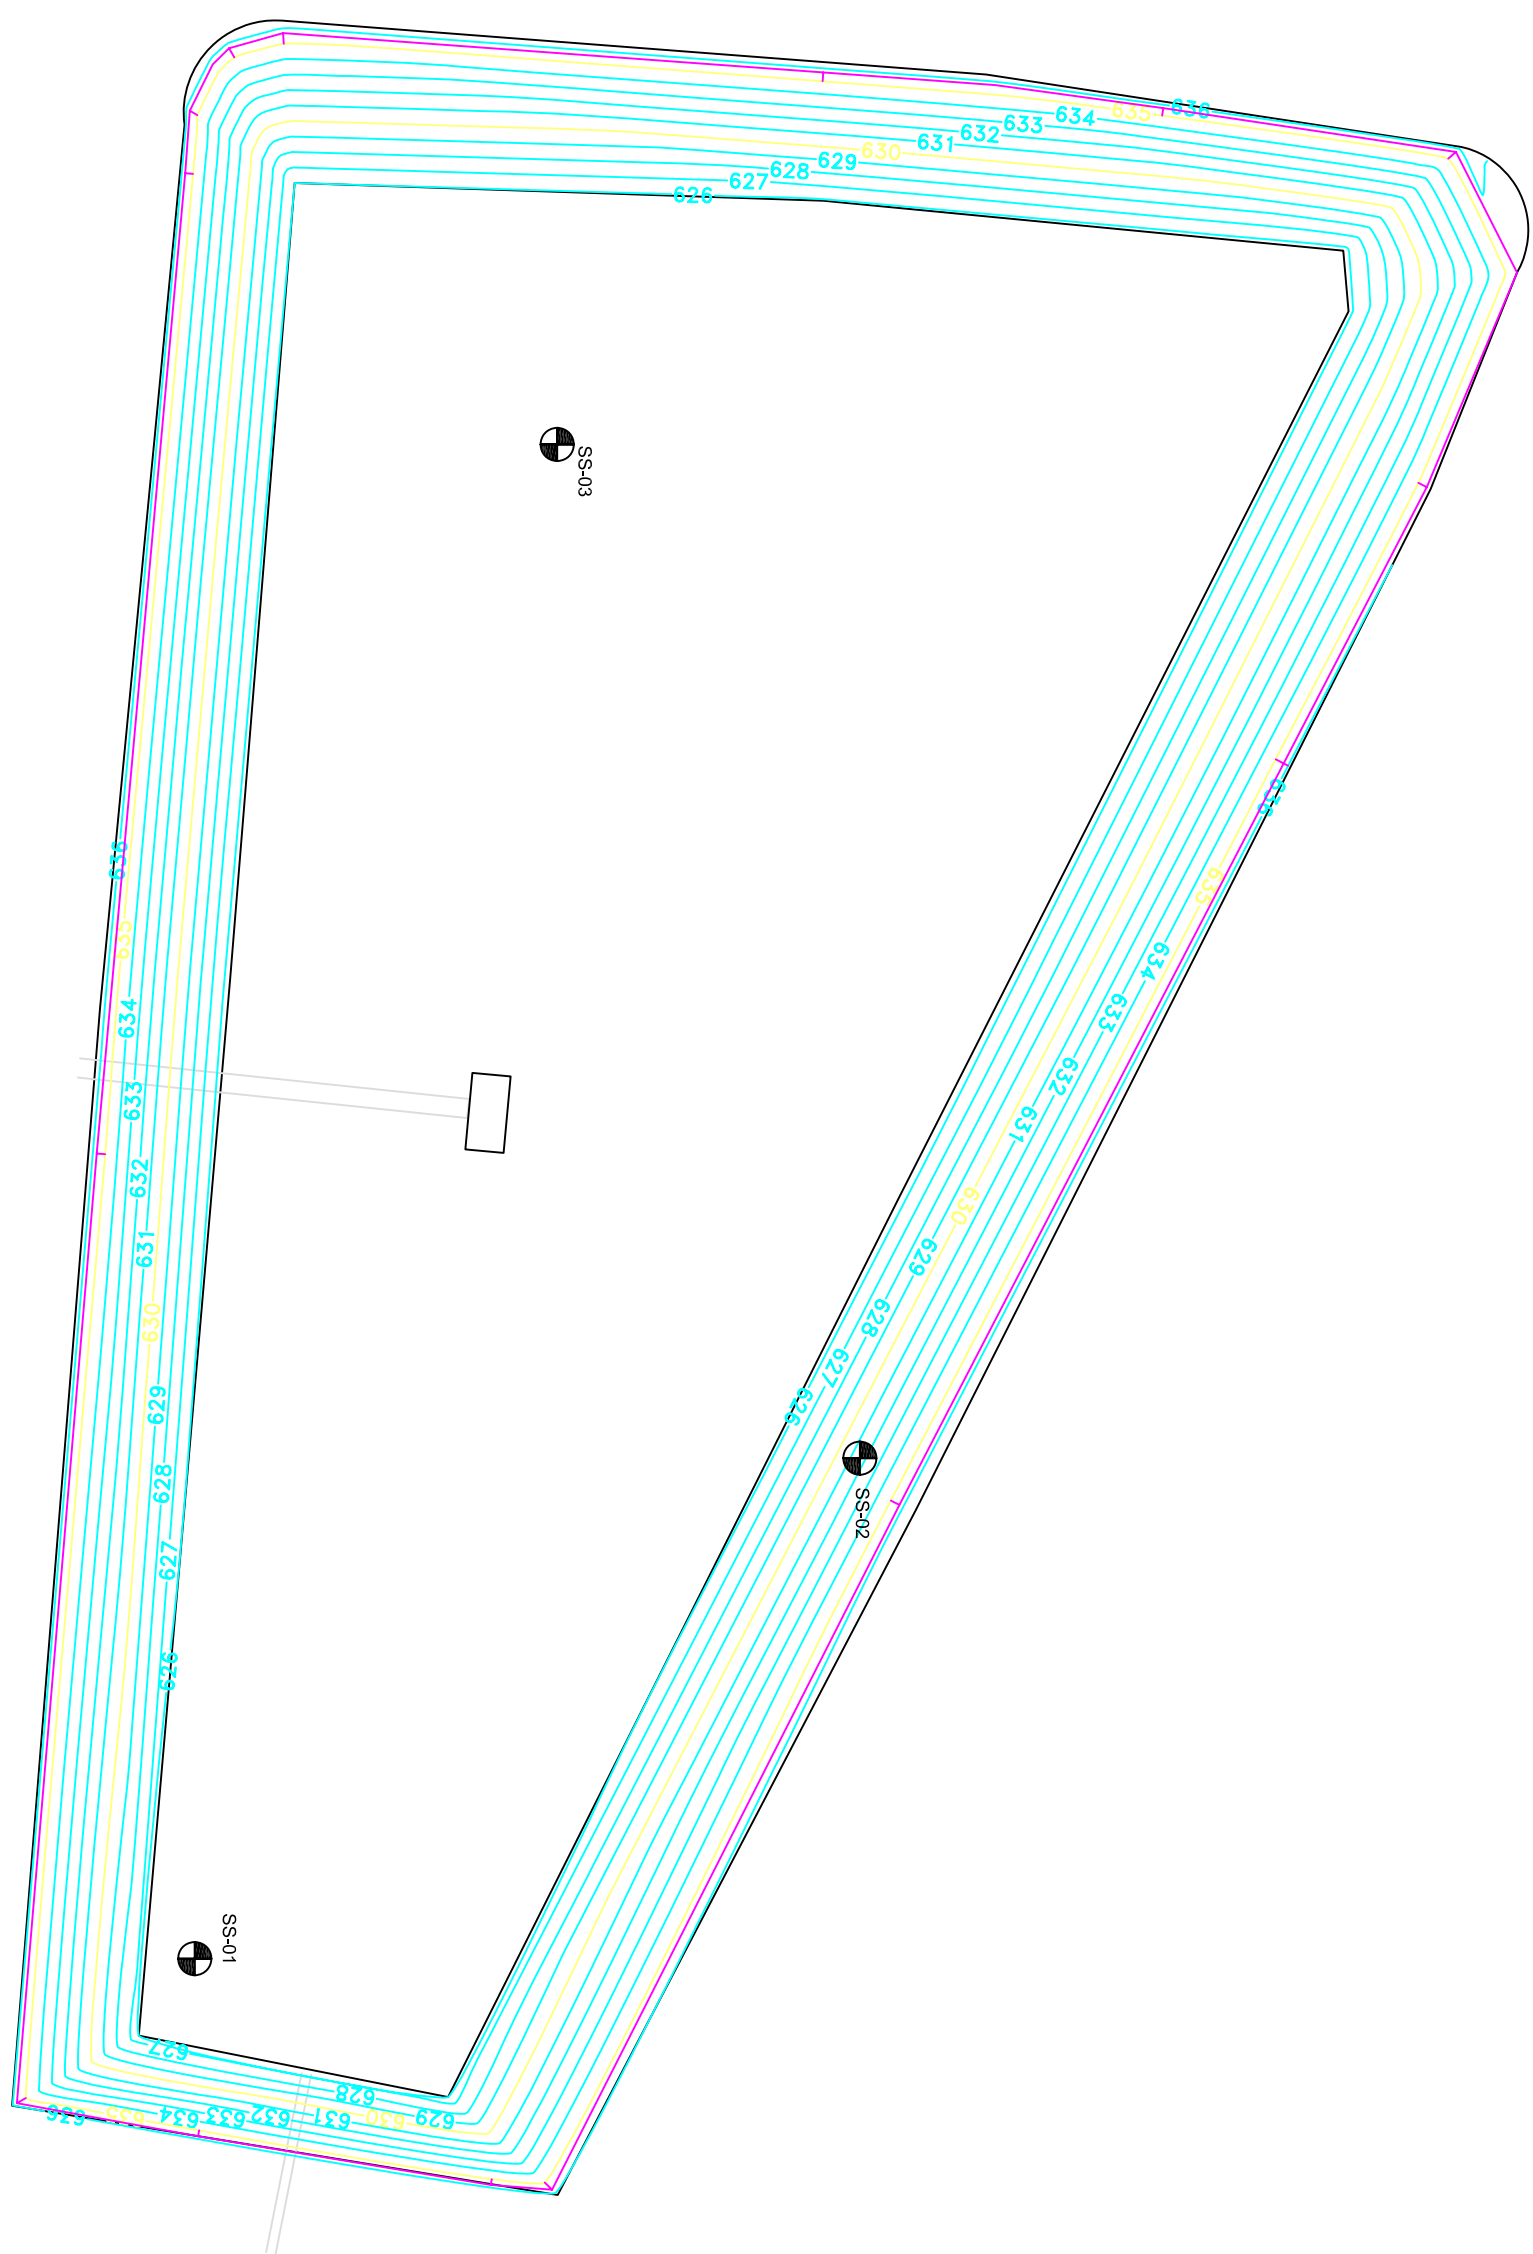
Figure 3  
Storm Water Pond Liner  
Sample Locations  
7471 South Fifth Street  
Frisco, Texas

Three areas of the pond liner, designated SS-01 through SS-03, were evaluated to assess the location, thickness and condition of the HDPE membranes, and the density and physical characteristics of the

underlying compacted soil. Sample locations are presented on **Figure 3**. During investigation of the pond liner system, it was observed that at least two layers of HDPE were overlaying the soil liner. The liner was cut using a box-cutter knife equipped with a hook-shaped blade. The uppermost liner was comprised of 60 mil HDPE and subsequent layers were determined to be 40 mil HDPE. The presence of the 60 mil liner directly above the 40 mil liner is consistent with the information provided by Exide regarding the repair of the entire liner system after a storm in the early 1990s. Both the 60 mil and 40 mil HDPE liners meet the required thickness of a plastic/rubber liner outlined in the TPDES permit. The HDPE liners located below the uppermost 60 mil liner are not believed to be exposed to the elements, ozone, or ultraviolet rays.

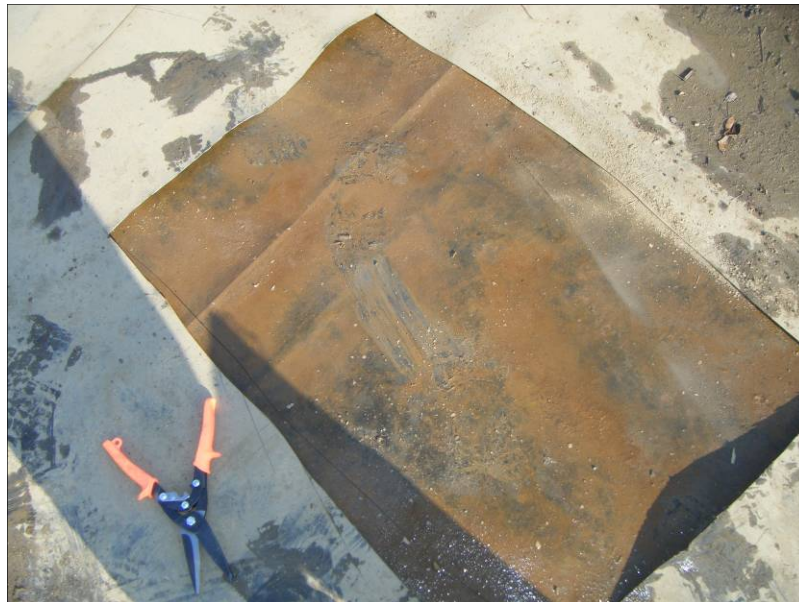
**Photo 2: Second layer of HDPE liner (40 mil) revealed after the top HDPE liner (60 mil) was removed in the area of soil sample SS-01 located in the southeast corner of the pond.**

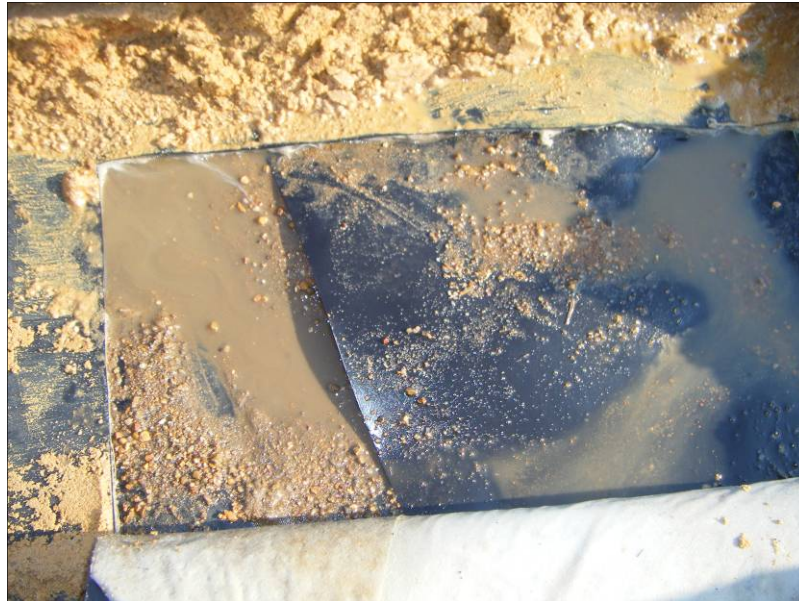
**Photo 3: Photograph depicting the layers of lining at surface soil sample SS-01. Six-inches of fill sand underlying the top two layer of HDPE and underlain by a 40 mil HDPE layer, a geotextile layer, and two more HDPE layers.**

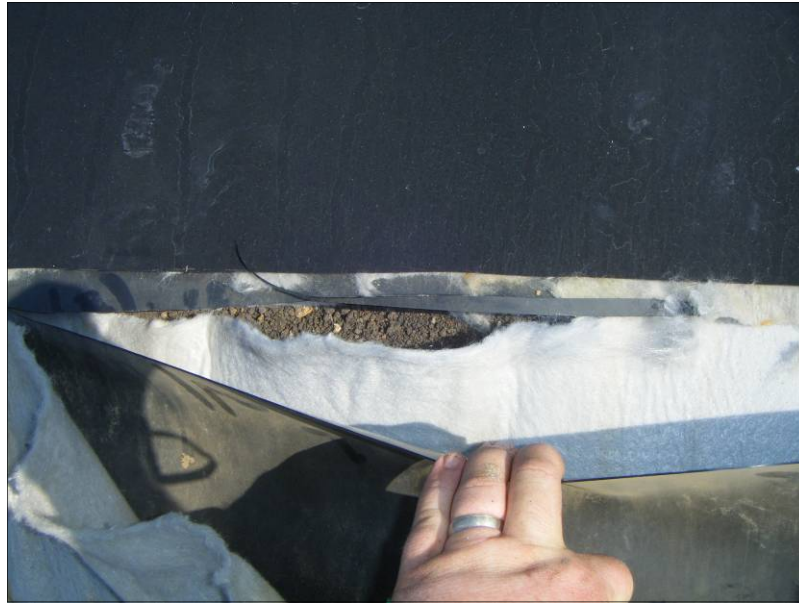
**Photo 5: Photograph depicting the layers of lining at surface soil sample SS-02 located on the north sidewall. A layer of 60 mil HDPE lining underlain by a geotextile fabric, underlain by a 40 mil liner, underlain by a geotextile fabric, underlain by a clay liner.**

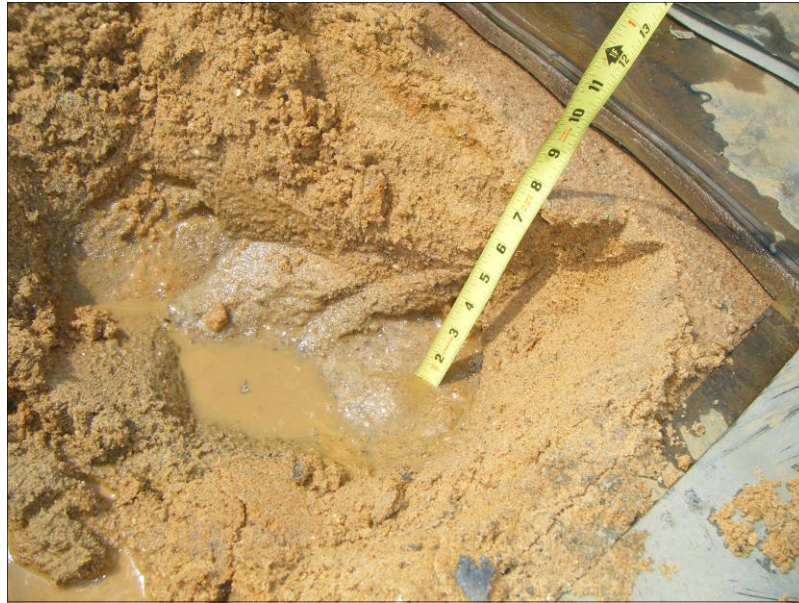
**Photo 7: Photograph depicting a 60 mil HDPE layer underlain by a 40 mil layer, underlain by an 8 inch layer of fill sand, underlain by another 40 mil HDPE layer.**

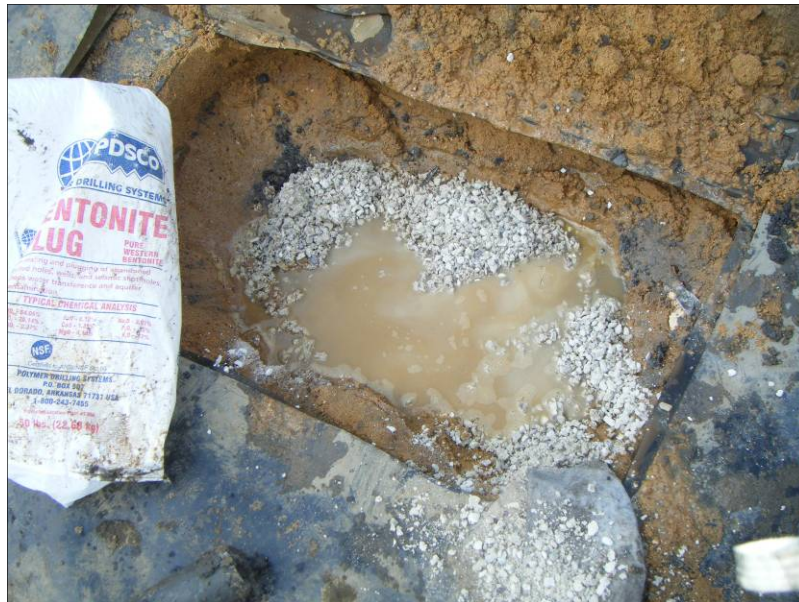
**Photo 8: Plugging the open holes in the pond liner with bentonite chips prior to covering it with fill sand and sealing it with two layers of 40 mil HDPE using extrusion welding methods.**

Sampling locations were filled with bentonite chips to match grade and the HDPE liners were repaired by Lone Star Lining Company, an experienced liner installation and repair company, using extrusion welding methods with two layers of 40-mil HDPE liner.

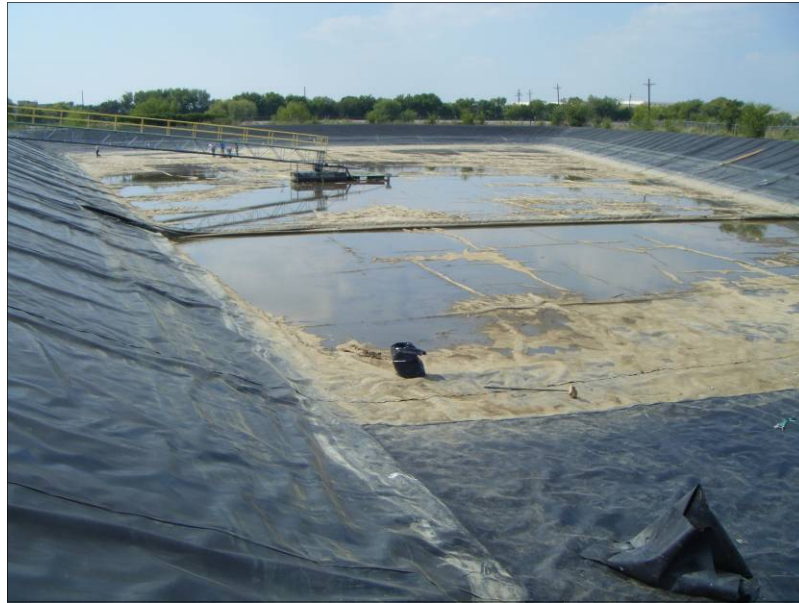
**Photo 9: Photograph depicting a new layer of 40 mil HDPE installed on the east end of the storm water detention pond and the pond liner repair crew repairing the liner at soil sample SS-03.**

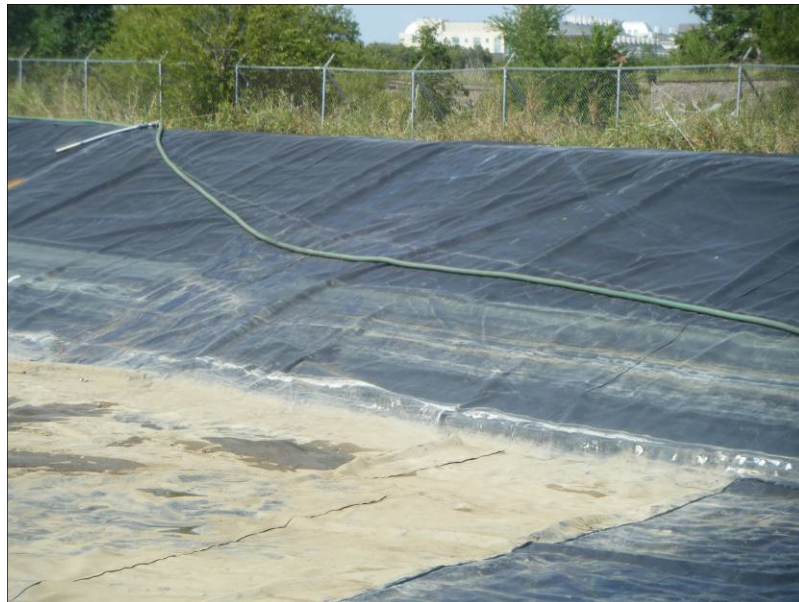
**Photo 10: North sidewall of pond showing repair of the liner breached to collect soil sample SS-02.**

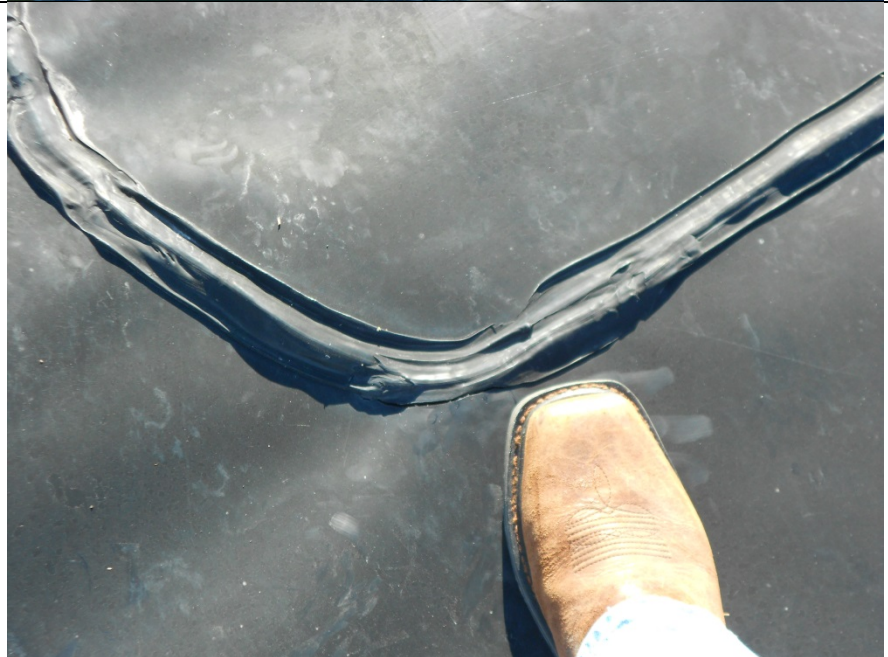
**PHOTO 6 - SWRP**

The second defect appears to be a cut in the HDPE liner that may be a remnant from the original liner installation. As shown on Photo 6, a cut immediately adjacent to a fusion-welded patch exists in the northwest corner of the pond. The cut appears to be approximately 6 inches in length, and is located

Cut in Liner at Patch (located above Crest of Pond Liner at Northwest Corner of Pond). Note damage (6-in cut) at toe of boot, along extrusion weld.

Two defects were observed in the liner material, although neither exists below the crest elevation of the liner, and can be addressed in the future as maintenance items.

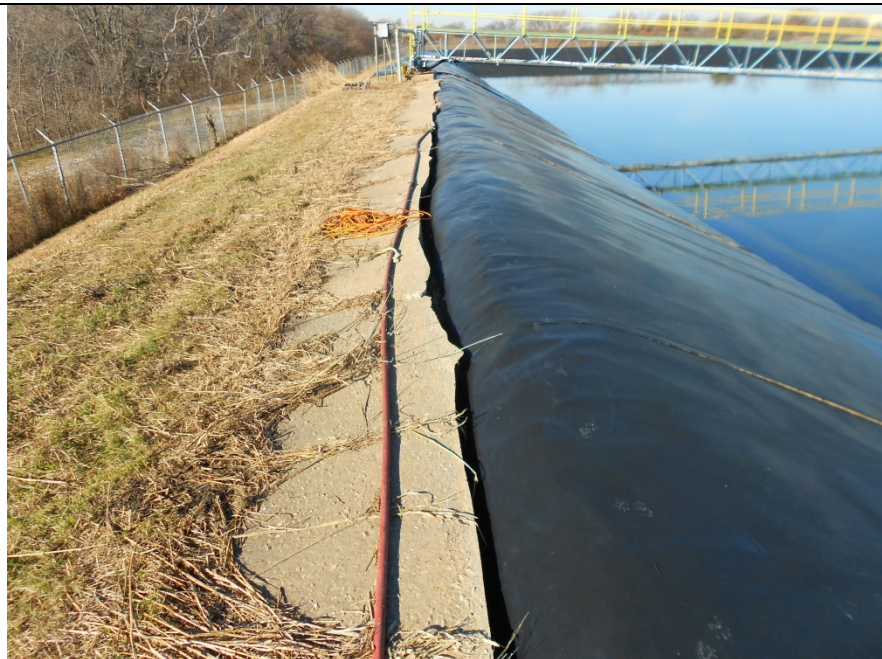
**PHOTO 7 - SWRP**

As shown in a number of photographs, a separation has opened between the liner and the concrete backfill believed to have originally been placed within the anchor trench around the perimeter of the pond liner. Vegetation was observed to have become established at several locations between the liner and the concrete, although it is apparent the vegetation has now been cut and removed. Root systems were observed still existing in the opening between the liner and concrete.

Separation of Concrete  
Anchor Trench Fill and  
Liner at Southern Slope of  
Pond

Golder understands that the SWRP will be decommissioned over the next several years as a component of ongoing remediation being performed at the site. The opening between the concrete and liner does not appear to pose any short-term environmental risk or structural risk to the pond liner or slopes, and can remain in its current state until decommissioning. In the event future plans call for maintaining the pond indefinitely, then repairs might include backfilling the opening with concrete or compacted sand. Removal and replacement of the existing concrete backfill is not recommended, as potential damage to the liner or foundation soils is possible.

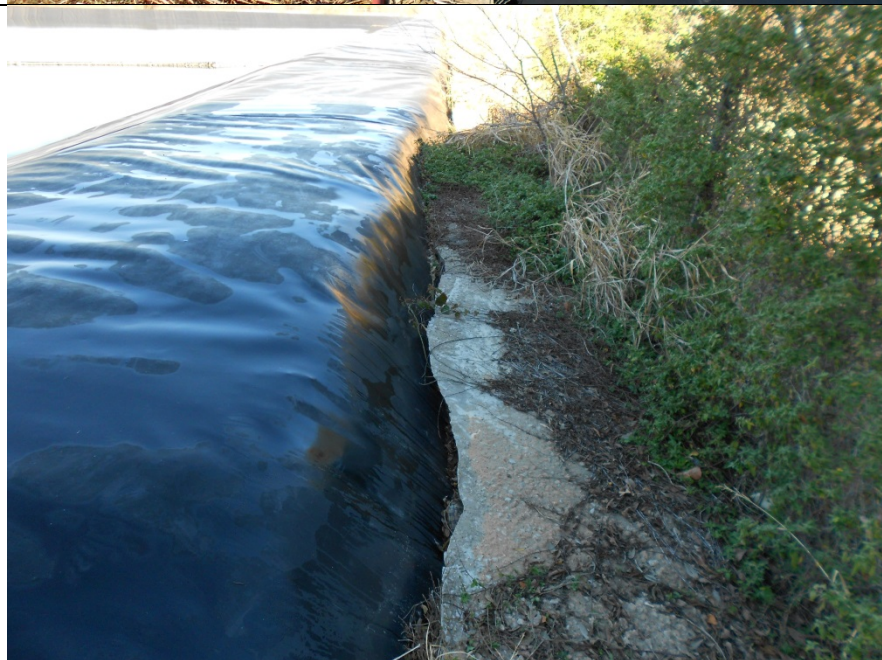
**PHOTO 8 - SWRP**

Separation of Concrete  
Anchor Trench Fill and  
Liner at Northern Slope of  
Pond

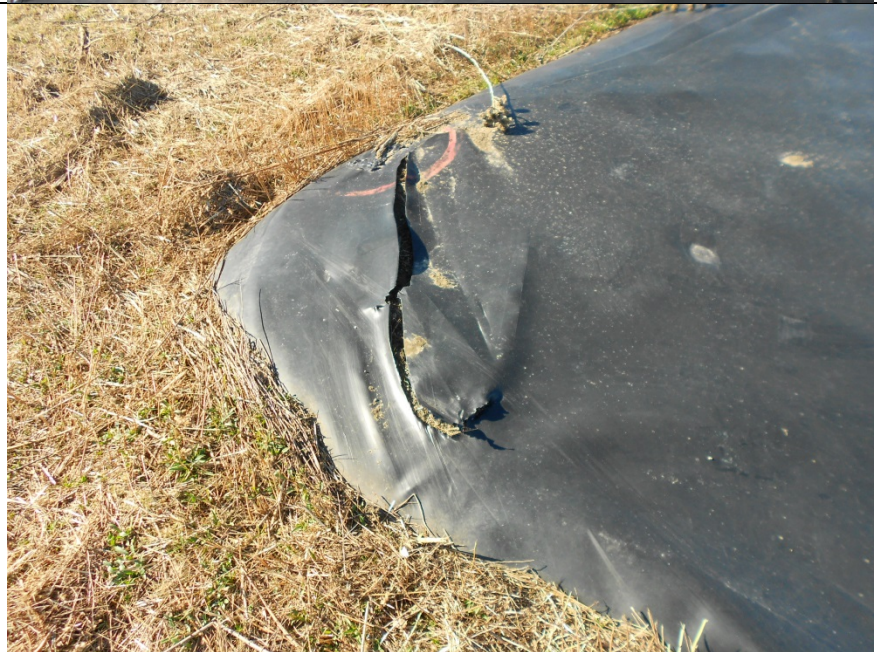
**PHOTO 14 - SEP**

The defect is located at the southeast corner of the pond, immediately adjacent to the anchor trench. The liner appears to have been torn, potentially by maintenance equipment (see PHOTO 14). The tear is at a location beyond the pond crest, and does not represent an environmental risk or a risk to the stability of the pond liner.

Liner Damage in Southeast Corner of Pond (Note: Damage Located at Elevation above Eastern Crest of Pond).

A single defect/damage was observed in the liner material, although the liner damage exists above the crest elevation of the liner, and can be addressed in the future as a maintenance item.
