APPENDIX 11
MISCELLANEOUS ASSESSMENTS – INTERIM ACTION REPORTS

Date:	May 19, 2014	Project No.:	130-2086
To:	Matt Love	Company:	Exide Technologies
From:	David E. Poe, P.E.		
cc:	File	Email:	
RE:	INSPECTION AND GEOTECHNICAL TESTING OF DISPOSAL AREA FINAL COVERS – EXIDE TECHNOLOGIES, FRISCO, TEXAS

RE: South Disposal Area Cap Repair Report
Exide Frisco Recycling Center
7471 South 5th Street - Frisco, Texas
TCEQ SWR No. 30516, TCEQ Hazardous Waste Permit No. HW-50206; TCEQ
Agreed Order Docket No. 2011-1712-IHW-E; EPA ID No. TXD006451090;
W&M Project No. 112.072

**REPORT ON INTERIM ACTIONS
SLAG AND BATTERY CASE FRAGMENT
REMOVAL AND DISPOSAL**

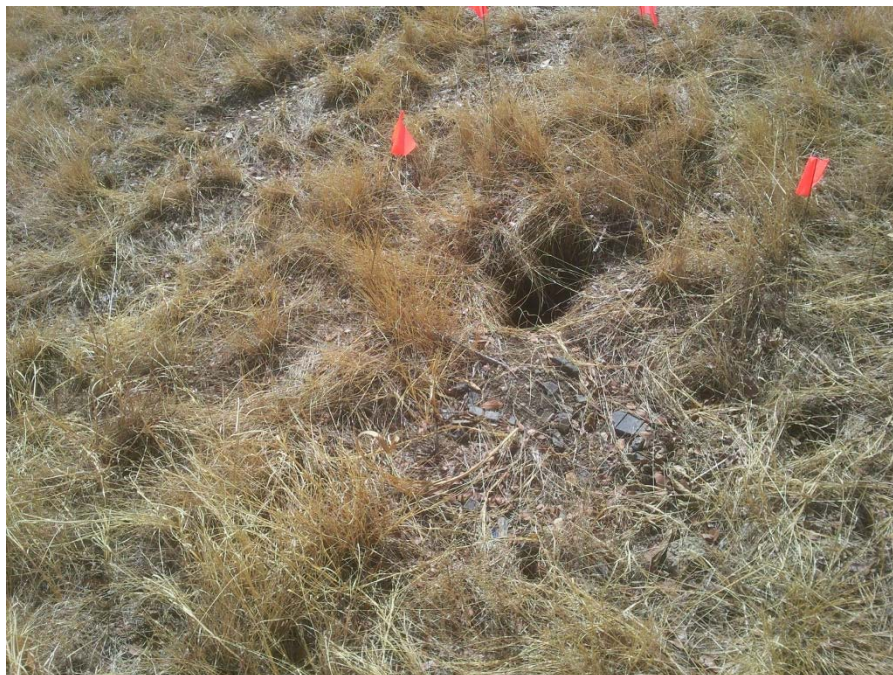
The most common type of disturbance in the cap consisted of animal burrows which occasionally resulted in small pieces of plastic or battery case fragments being brought to ground surface. Only a few areas of the SDA had experienced erosion, depressions, or areas of exposed slag. All 21 disturbances identified were targeted for repairs based upon the cap inspection.

Photo 3: Animal burrow with plastic chips exposed near entrance.

On June 5, 2013 W&M and RSI Remediation Services, Inc. (RSI) initiated SDA cap repair activities by filling each open hole or apparent cap penetration with fine gravel sized bentonite clay. Pin flags marking each disturbance were left in place for later capping with clay soil.

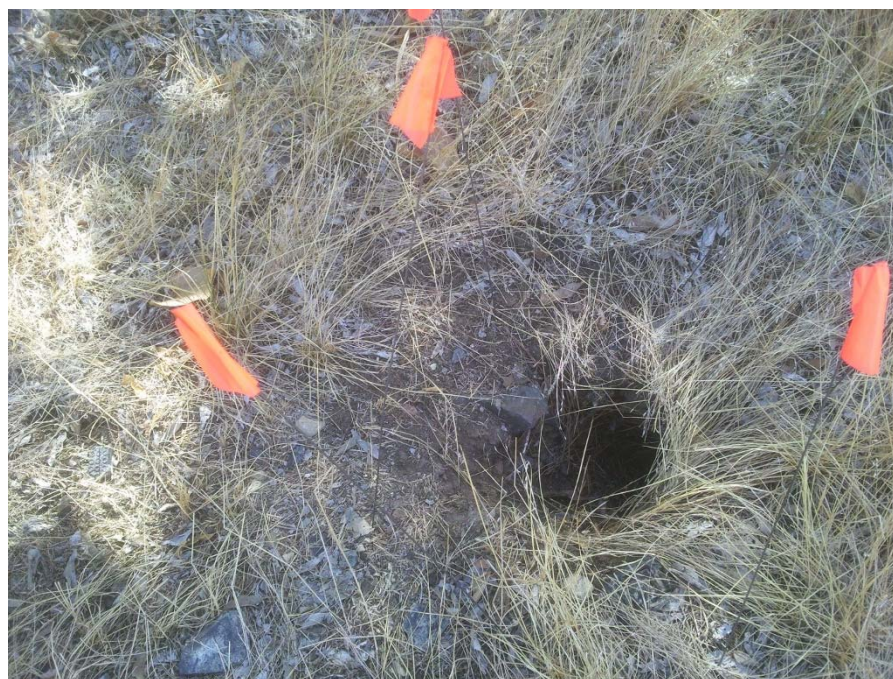
Photo 4: Slag material exposed by animal activity within the SDA.

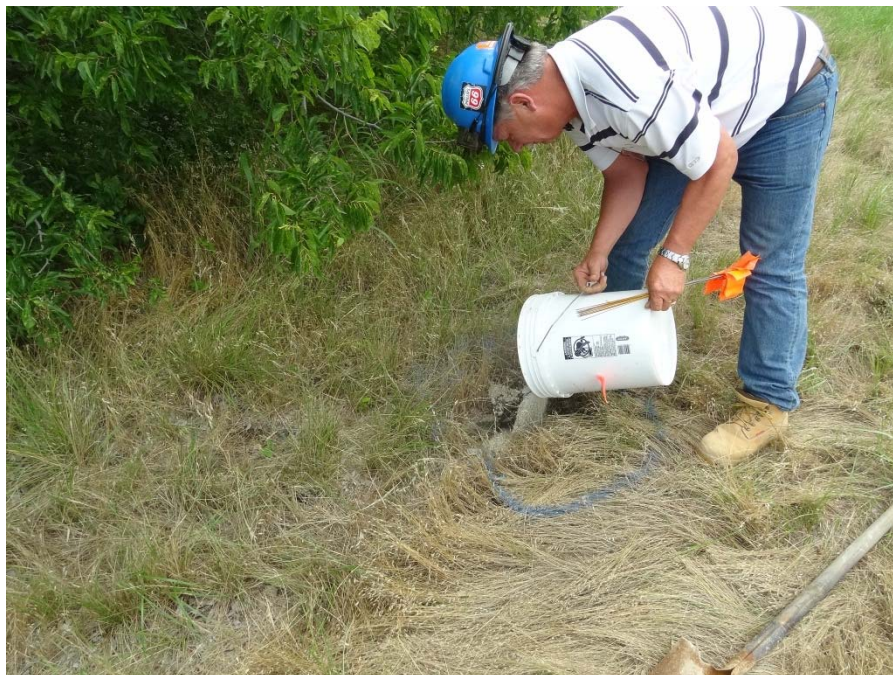
Photo 5: Filling of animal burrow within the SDA with fine grained bentonite chips.

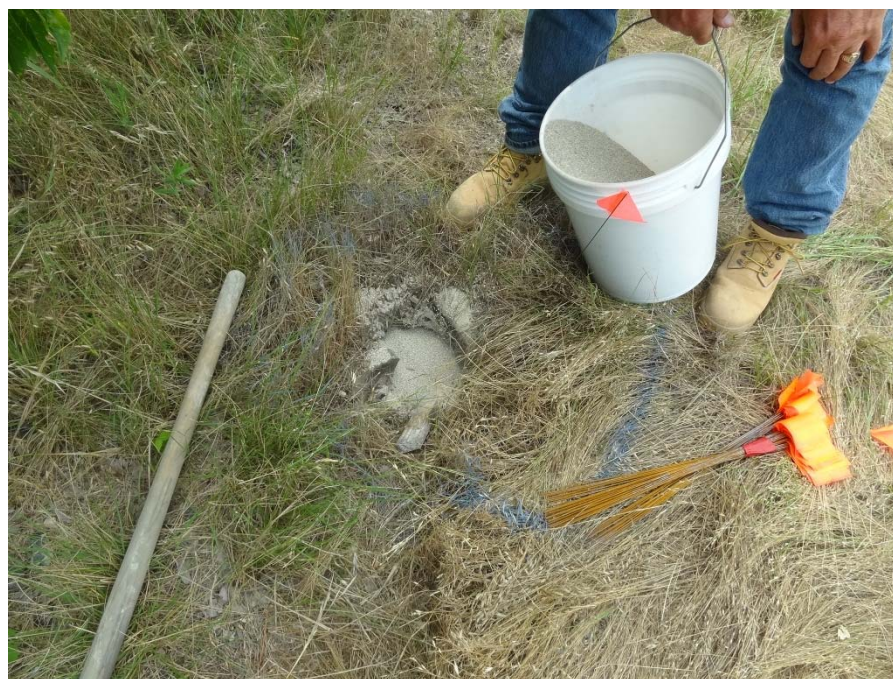
Photo 6: Bentonite filled animal burrow.

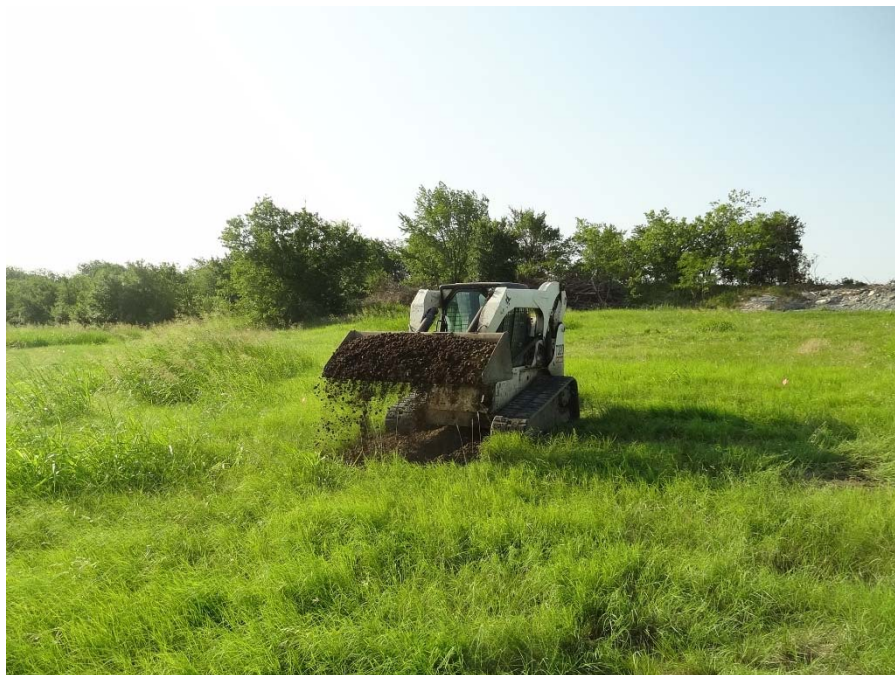
Photo 7: Capping animal burrow (cap-01) along western SDA boundary as viewed to the east.

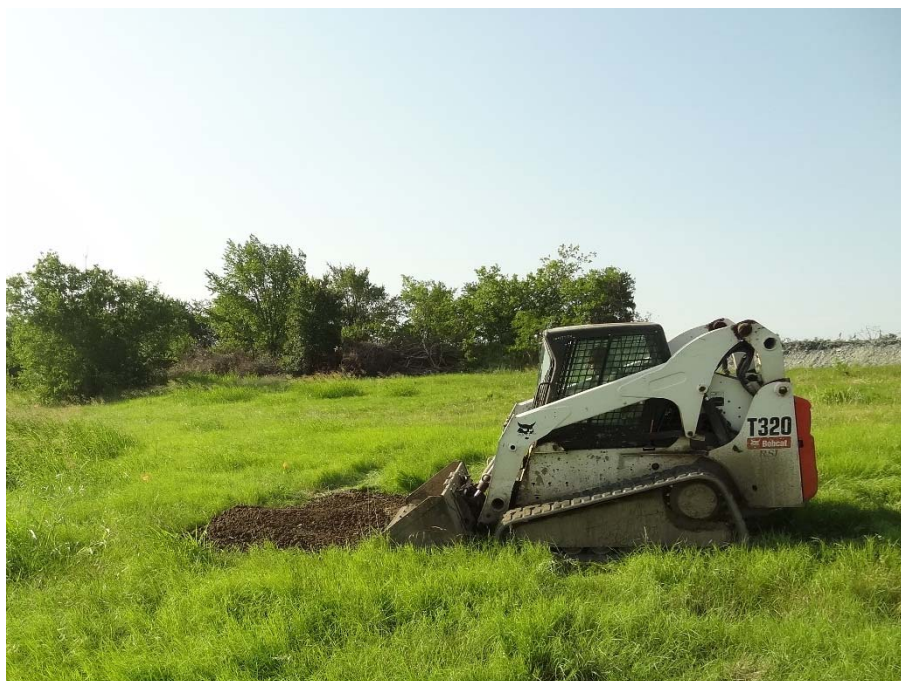
Photo 8: Feathering out clay cap.

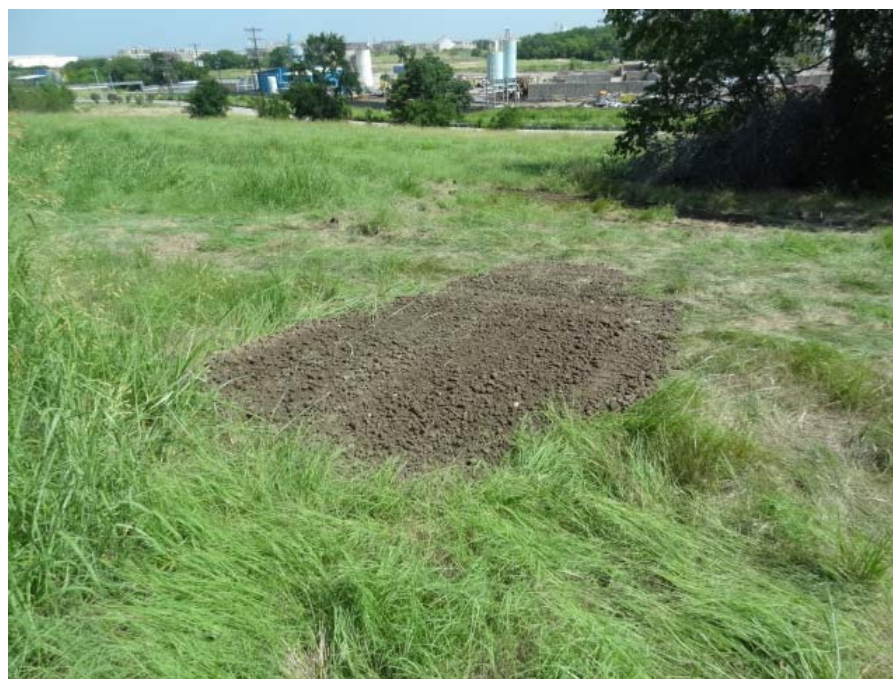
Photo 10: Completed spot cap in eastern portion of SDA as viewed to the South.

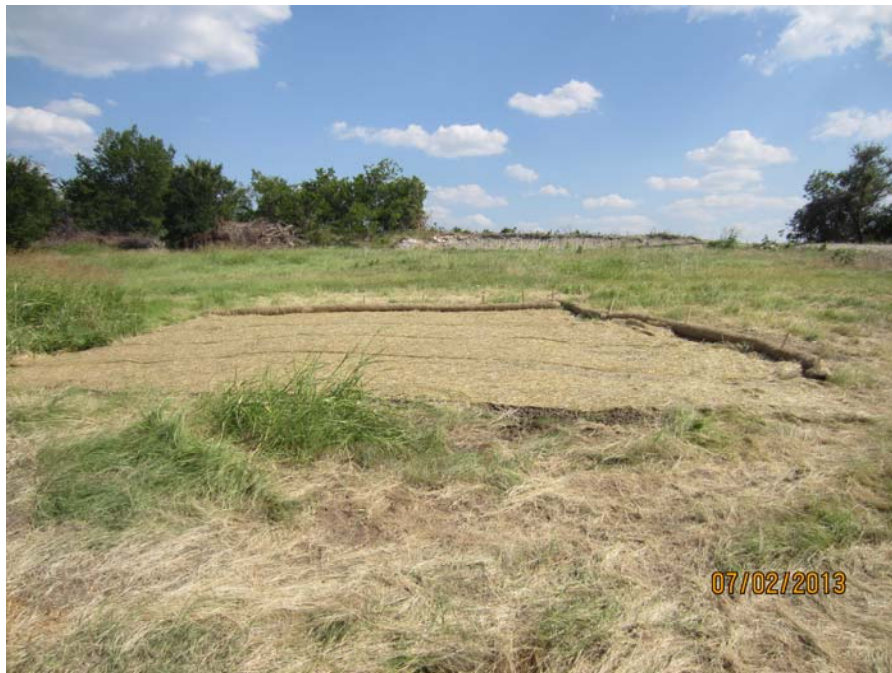
Photo 11: View of repaired area after placement of seed and erosion mats.

Areas of disturbance in the soil cap in the SDA were identified and systematically repaired to reinstate cap integrity. All identified areas were repaired by filling open holes with fine bentonite pellets and/or capped using clean imported soil, and stabilized using seed, straw mats and erosion control wattles.

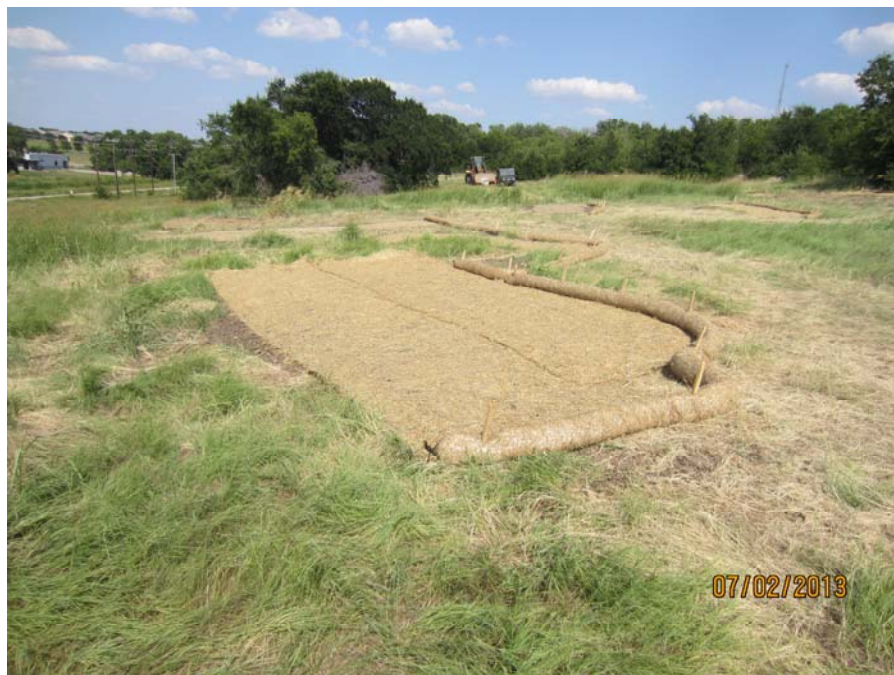
Photo 12: Completed area with erosion mat and wattle.

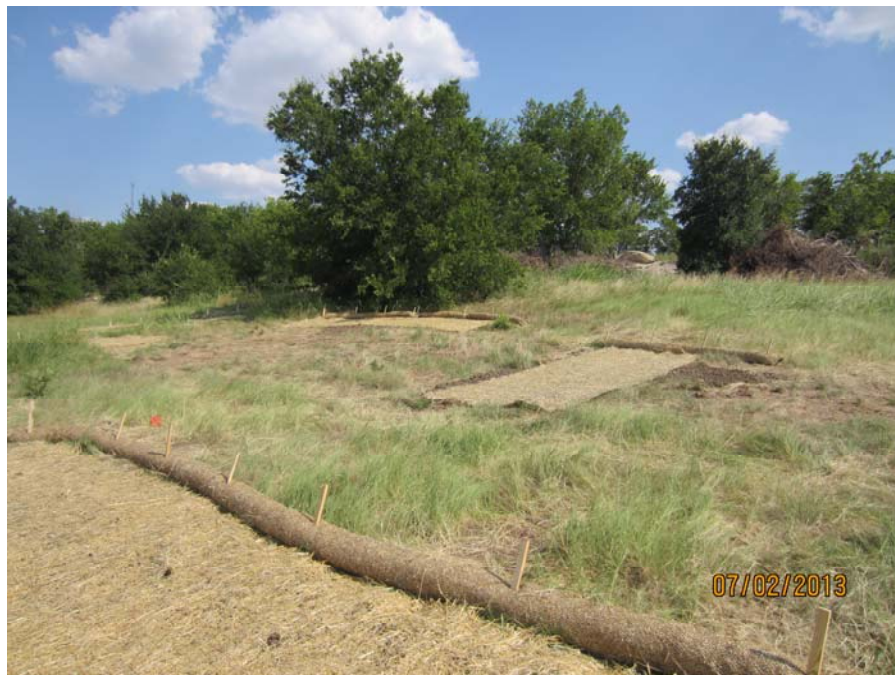
Photo 13: Multiple areas with erosion mat and straw wattles.

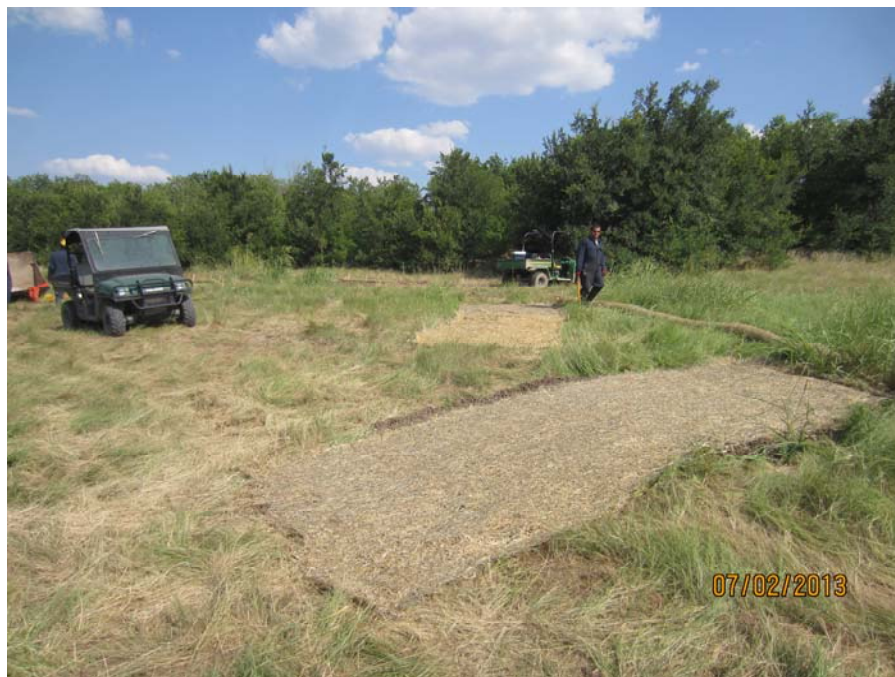
Photo 14: Completed area with erosion mat in place.

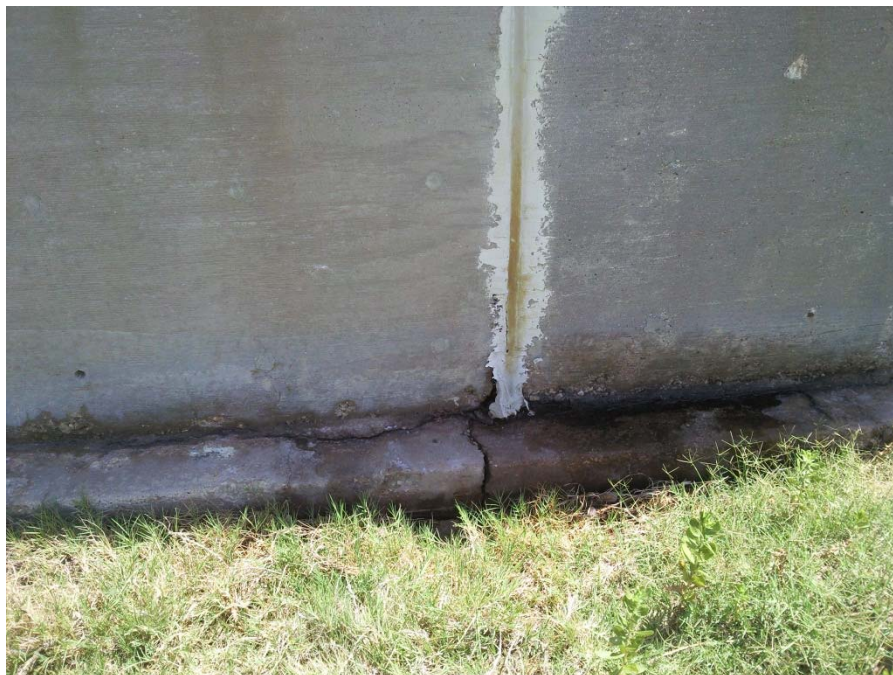
However, seepage continued in some areas and has resulted in spalling and deterioration of the exterior wall face, and localized areas of wet soil and/or small areas of standing water at the exterior base of the wall.

Photo 1: View of area of seepage along exterior face of retaining wall; note staining of caulking and cracks in concrete wall footing.

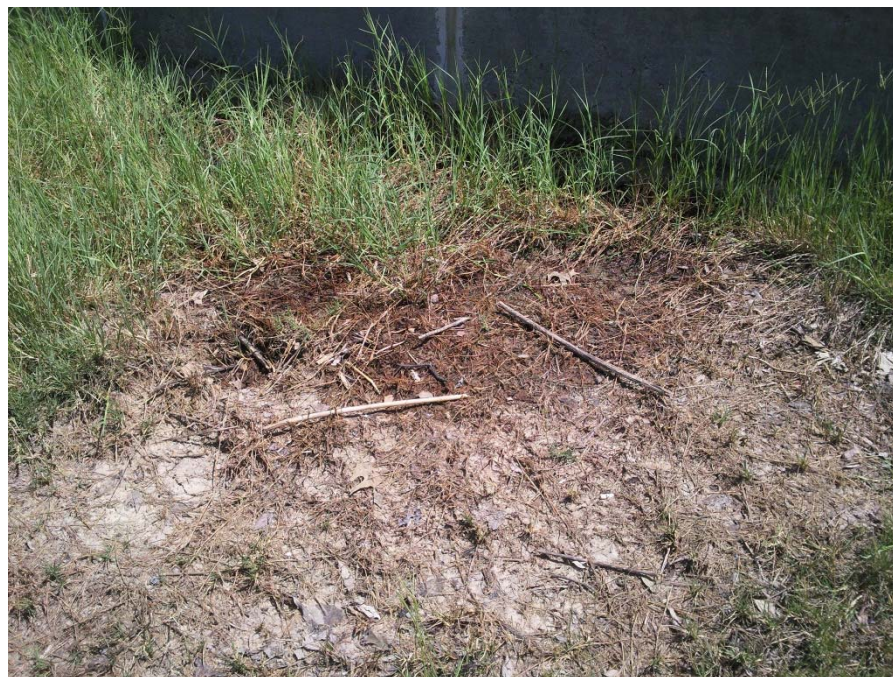
Photo 2: Area of moist soils near area of seep in wall.

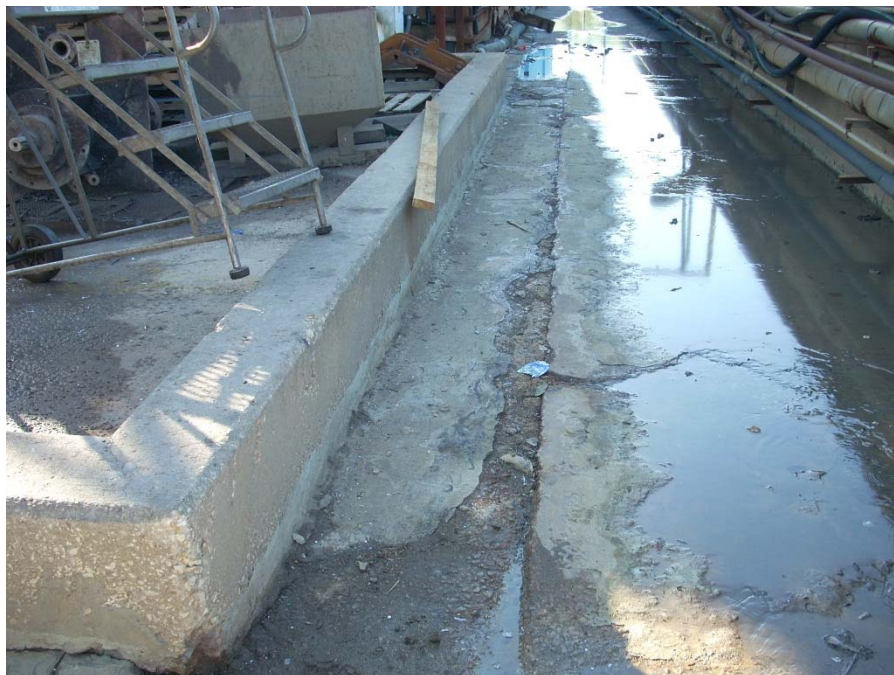
Photo 3: Pre-repair—deteriorated concrete pavement and standing water along retaining wall.

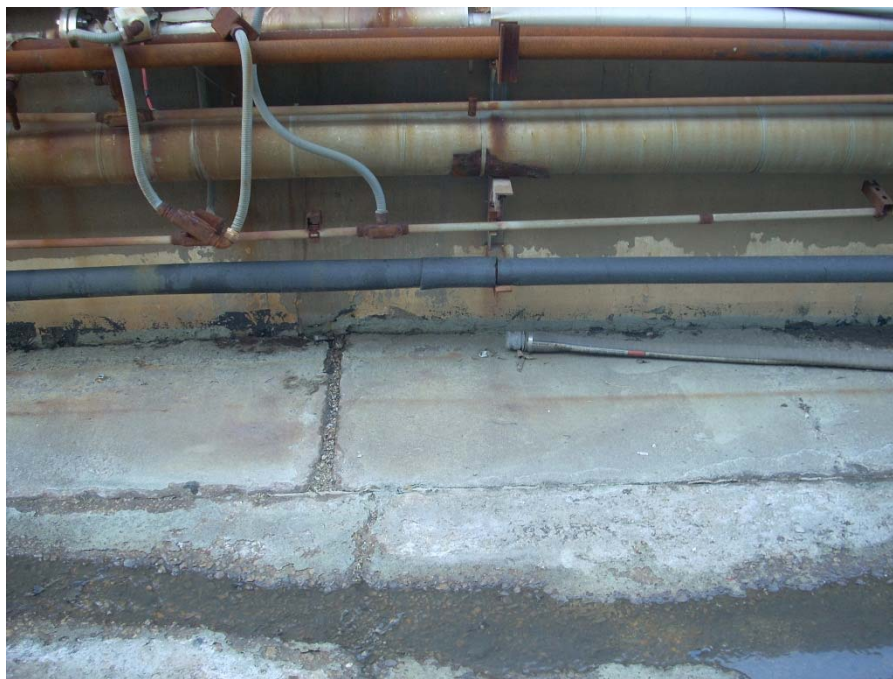
Photo 4: Deteriorated concrete and drainage swale that conveys water to sediment pit.

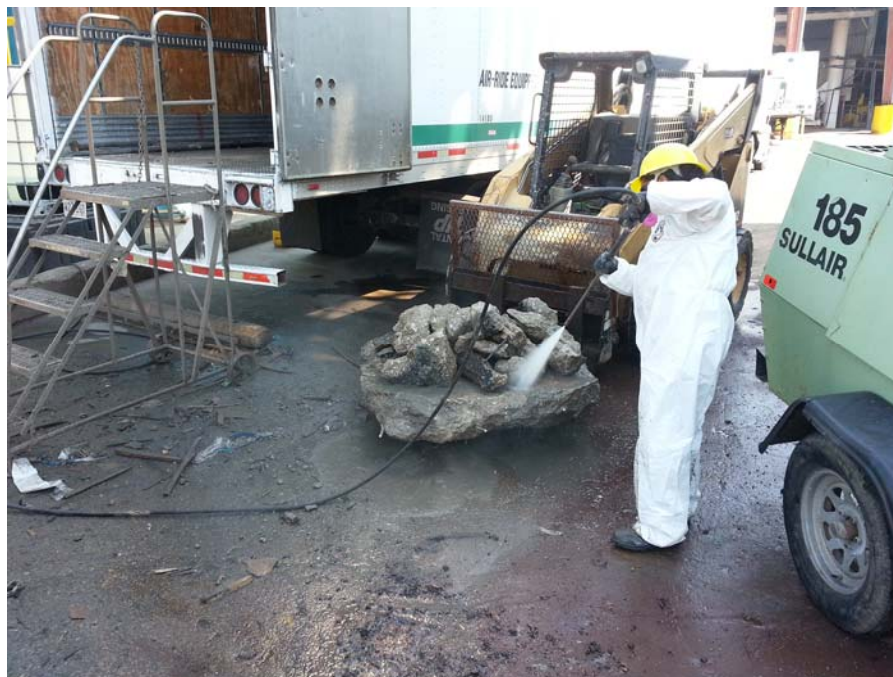
Photo 6: Pressure washing of concrete prior to removal and disposal.

Concrete removed from the drain area was broken into manageable sections and pressure washed at Exide's truck wash pit located adjacent to the work area. The concrete was then placed in an area designated by Exide and managed with other debris generated by the facility.

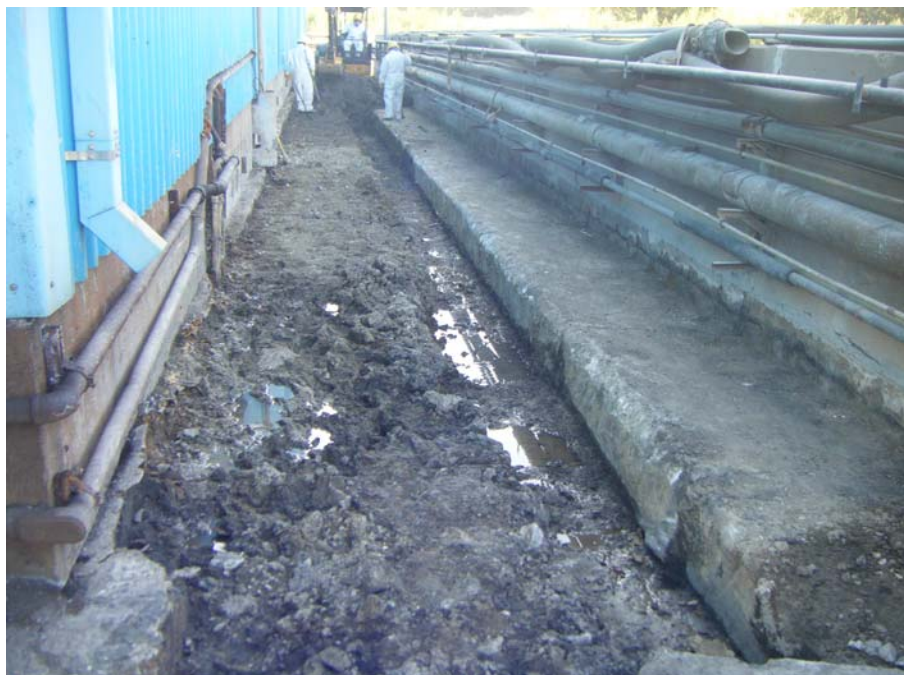
Photo 7: Exposed soil and back of retaining wall footing.

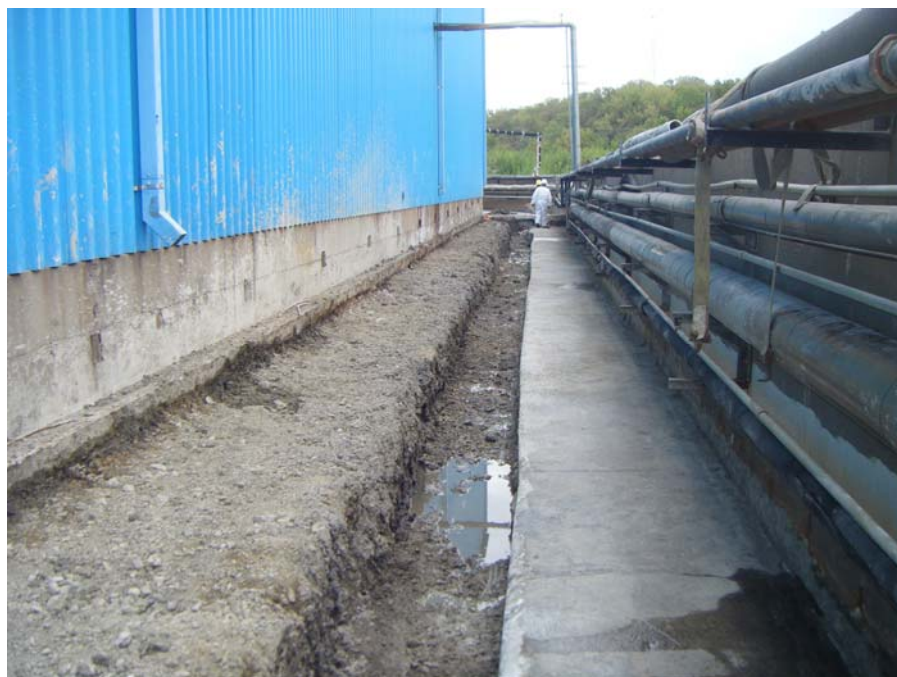
Photo 8: Trench at wall footing prior to installation of drain.

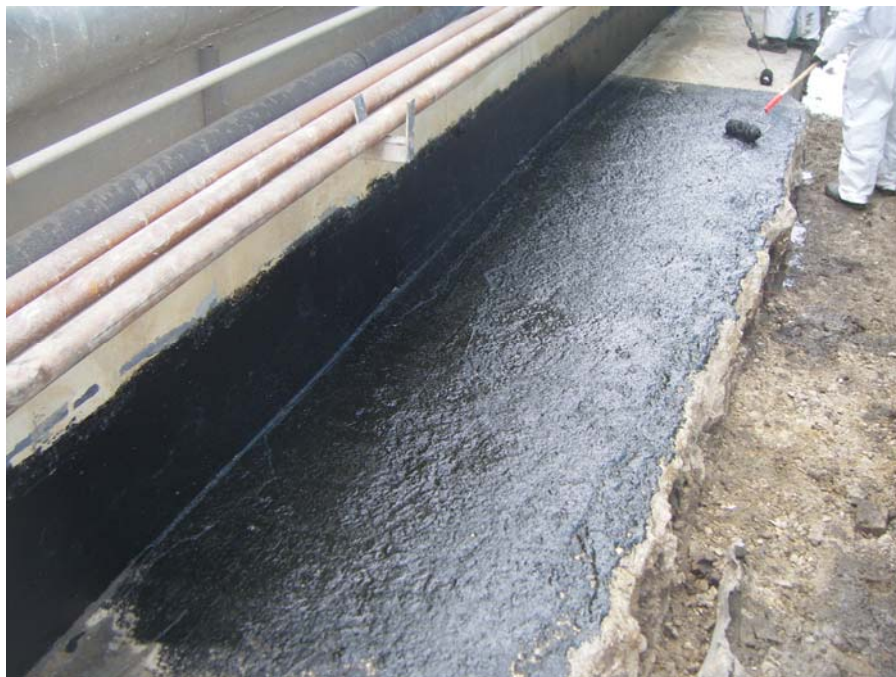
Photo 9: Applying liquid asphaltic membrane to wall and top of footing.

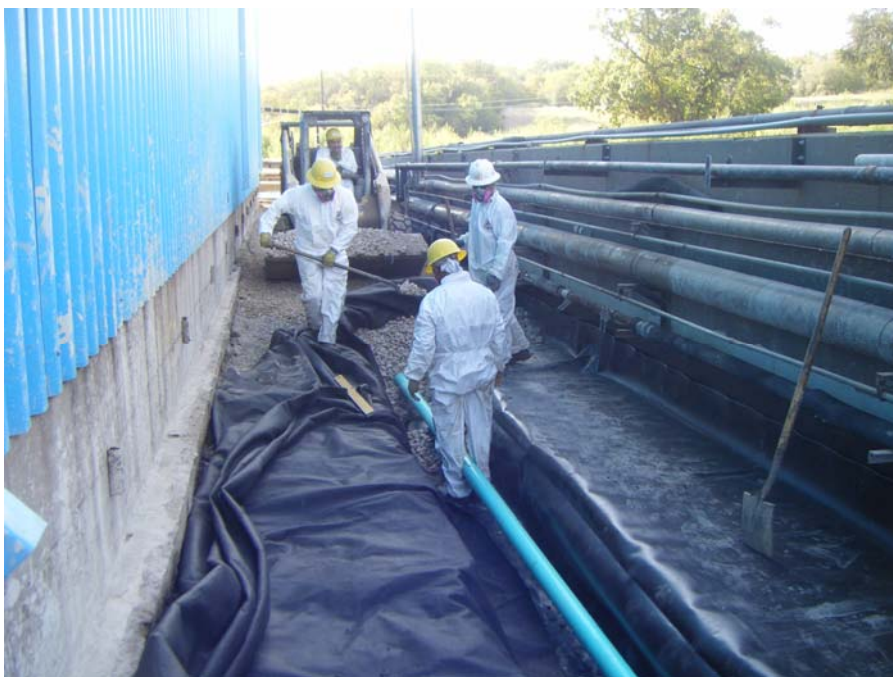
Photo 10: Installing filter fabric for footing drain.

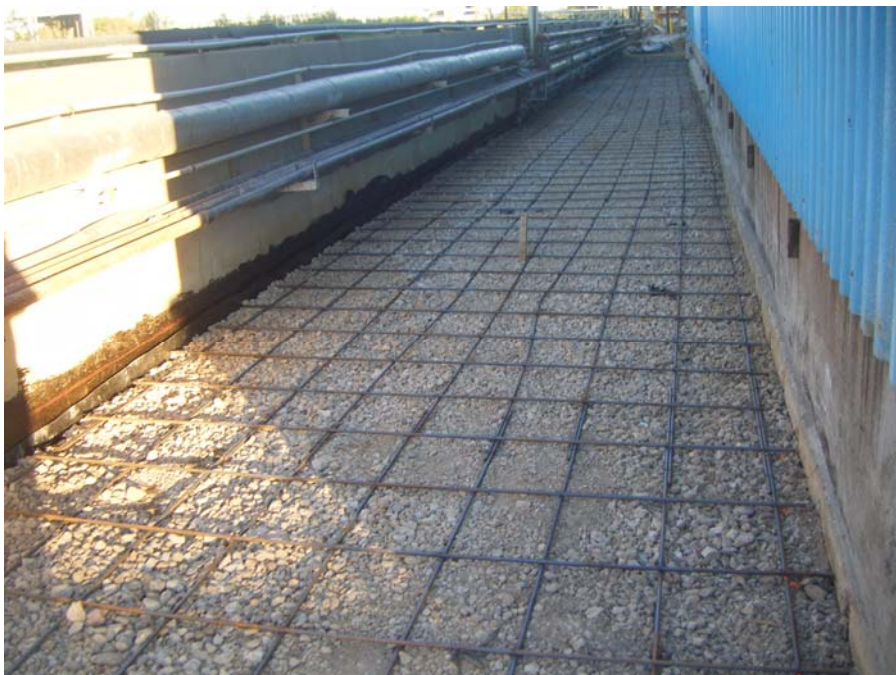
Photo 11: Re-bar installed on flex base awaiting concrete.

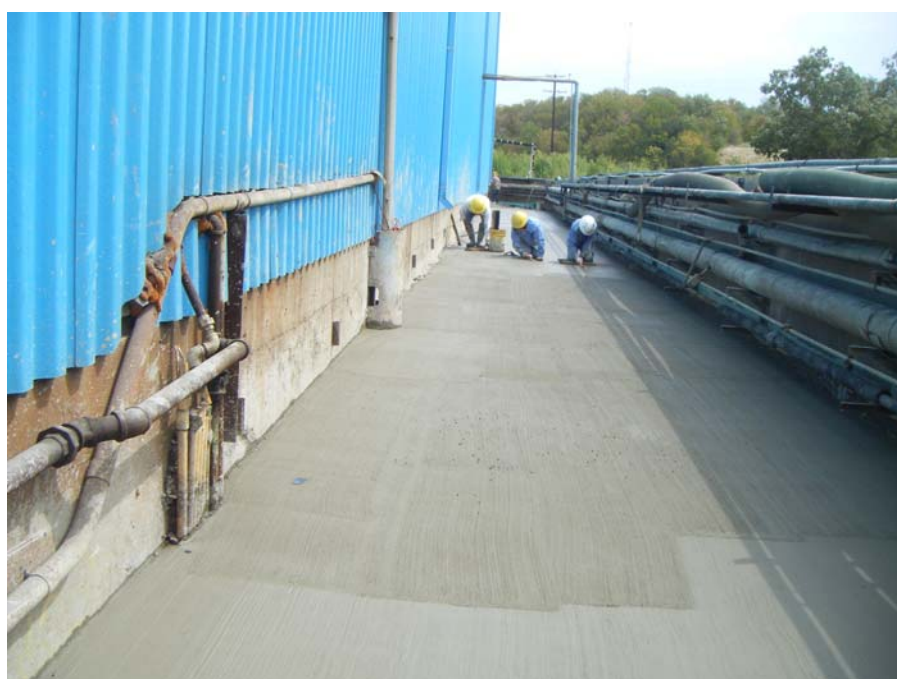
Photo 12: Finishing new concrete paved surface and swale.

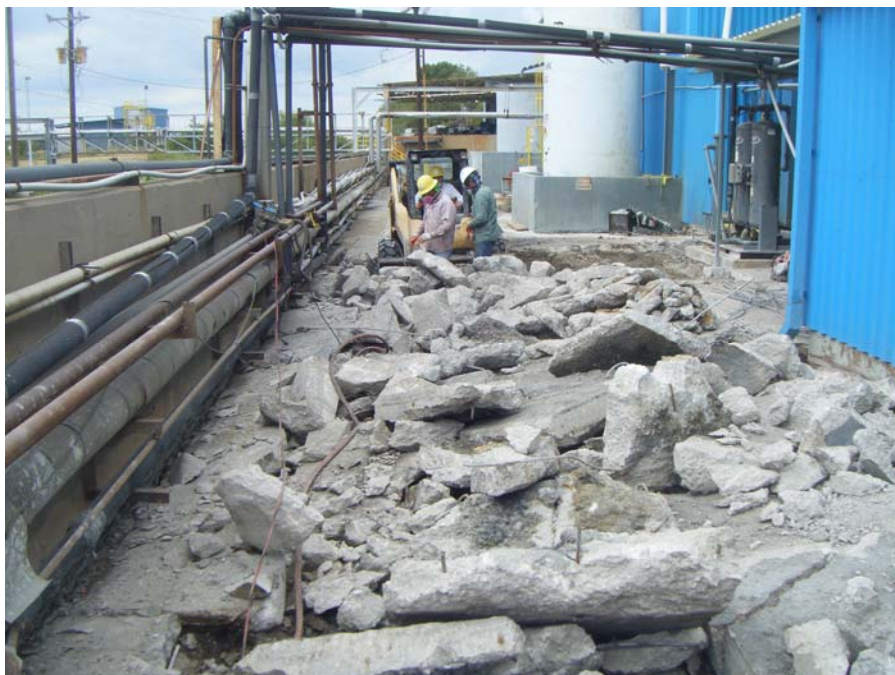
Photo 13: Broken concrete from second section .

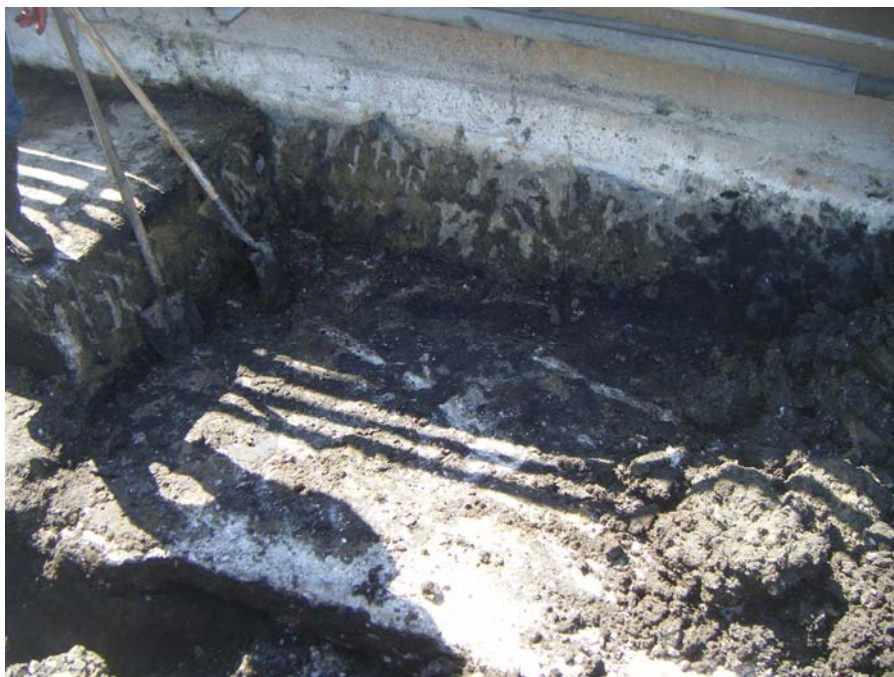
Photo 14: Exposed footing at step-down section.

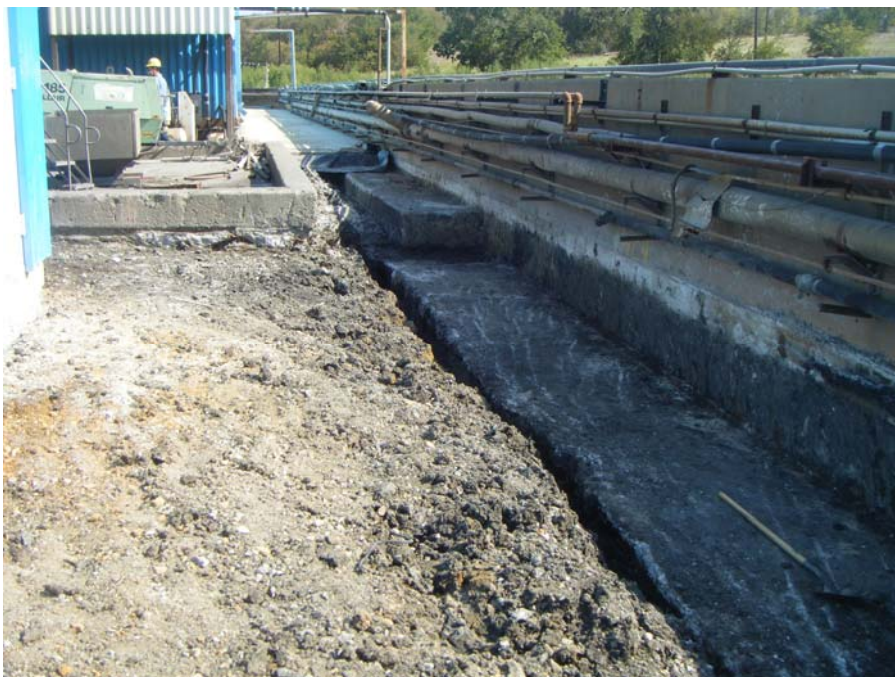
Photo 15: Exposed wall and footing near truck wash.

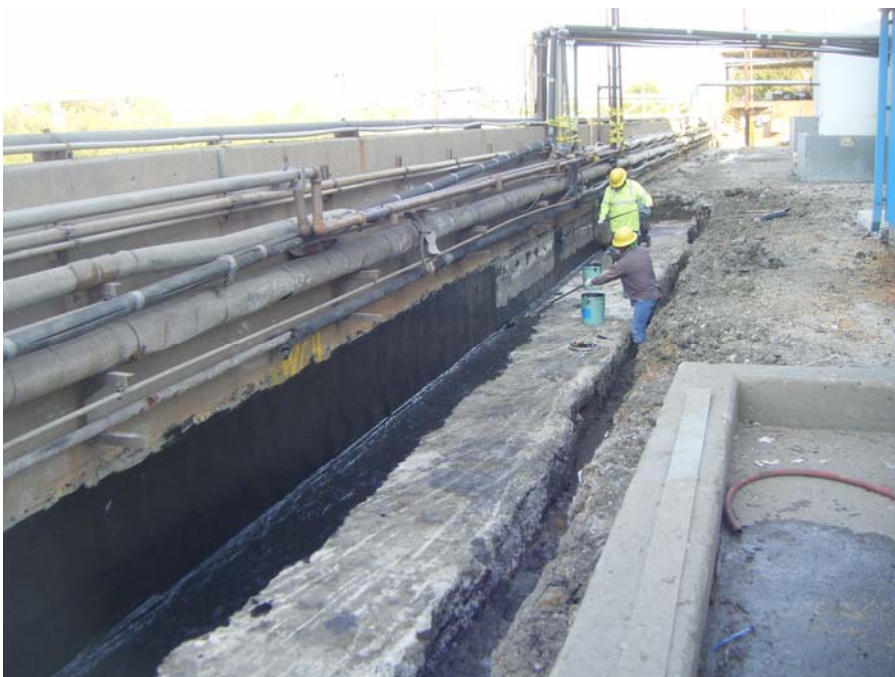
Photo 16: Applying liquid asphaltic membrane to wall stem and footer.

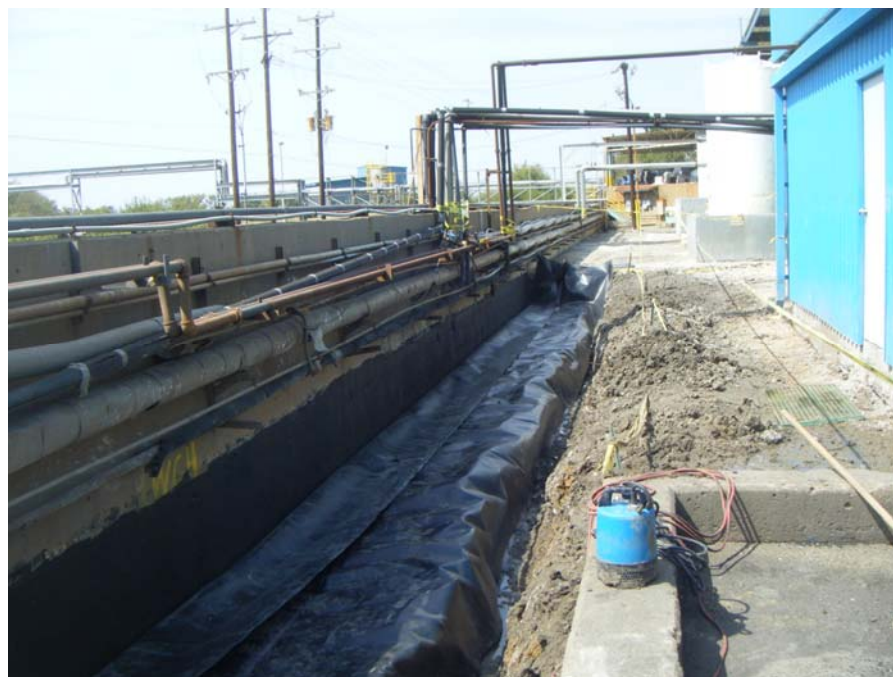
Photo 18: Installed liner prior to drain pipe and anchoring to wall.

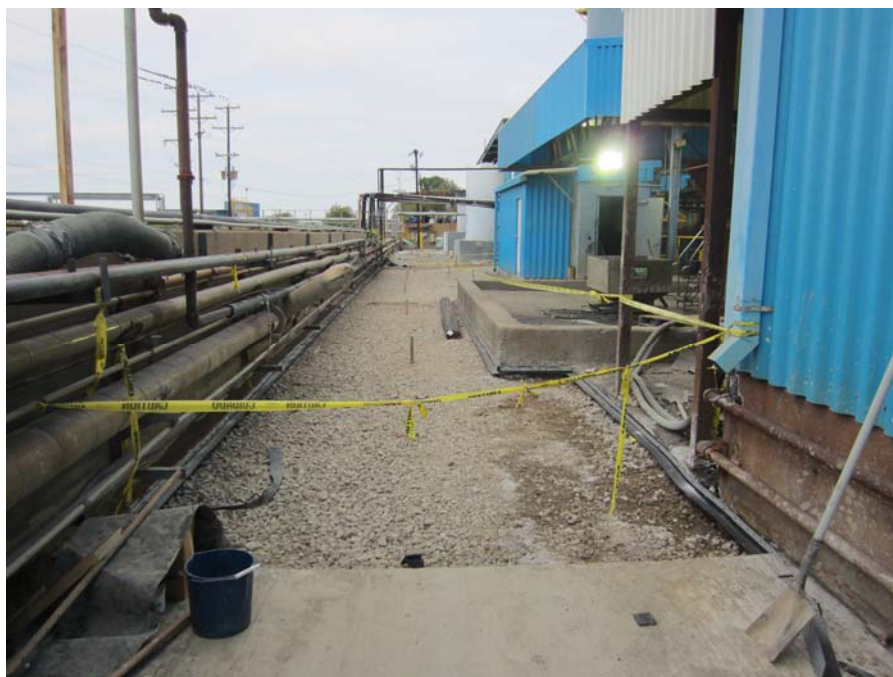
Photo 20: Second section prior to placement of steel.

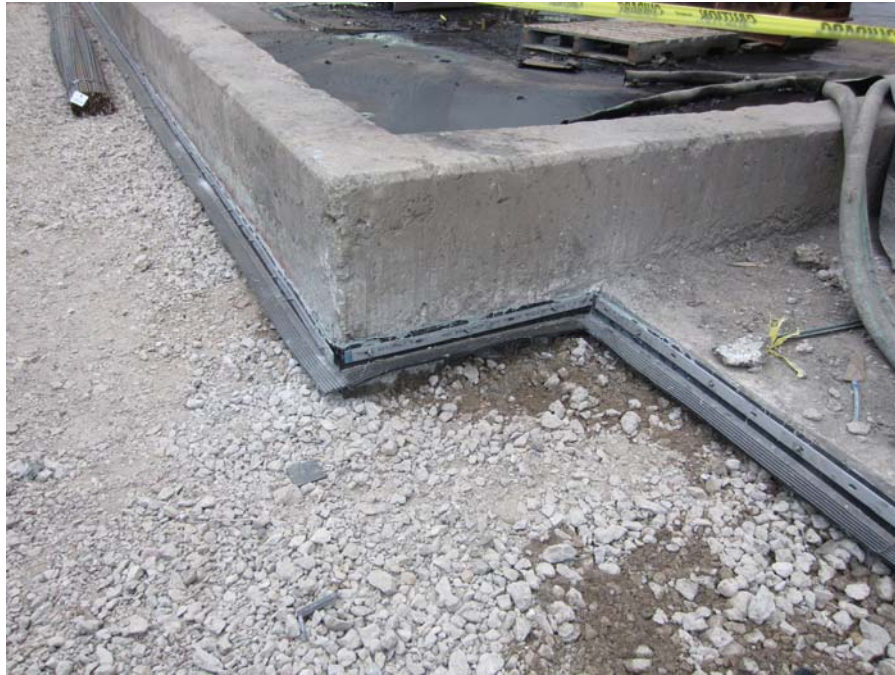
Photo 21: Water stop detail at corner.

- Two new collection sumps were constructed at the west end of the wall, one for the new underdrain system, and a second for surface runoff.
- Replacement of the removed concrete, including installation of chemical resistant waterstops.

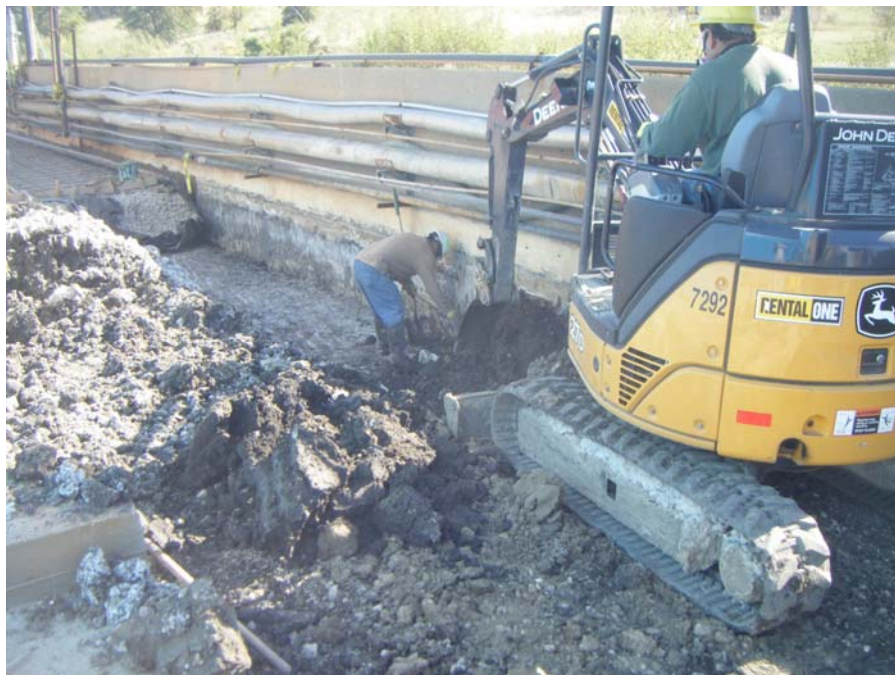
Photo 22: Excavating third section of drain.

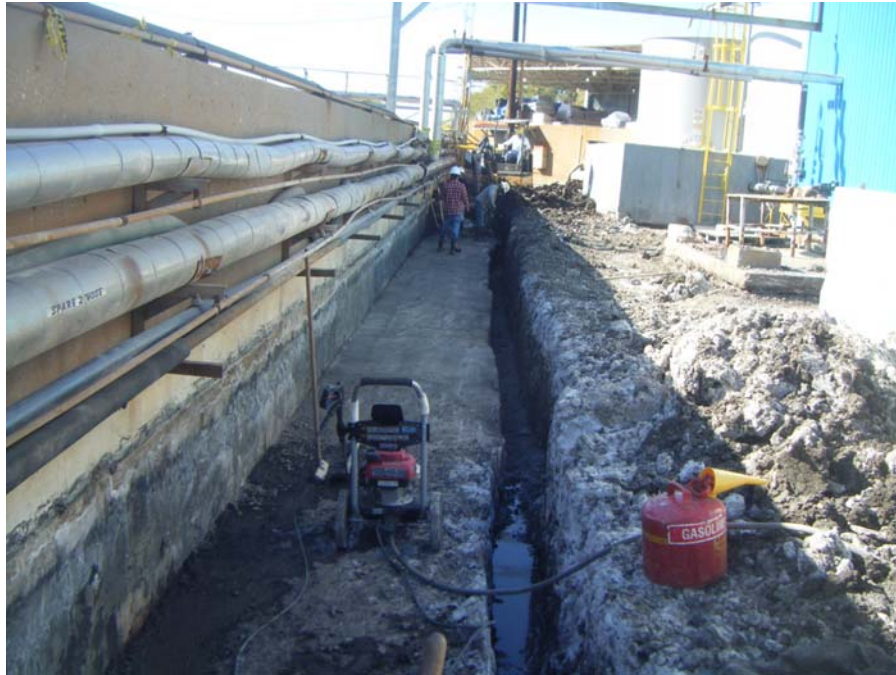
Photo 23: Exposed wall and drain trench prior to membrane and pipe.

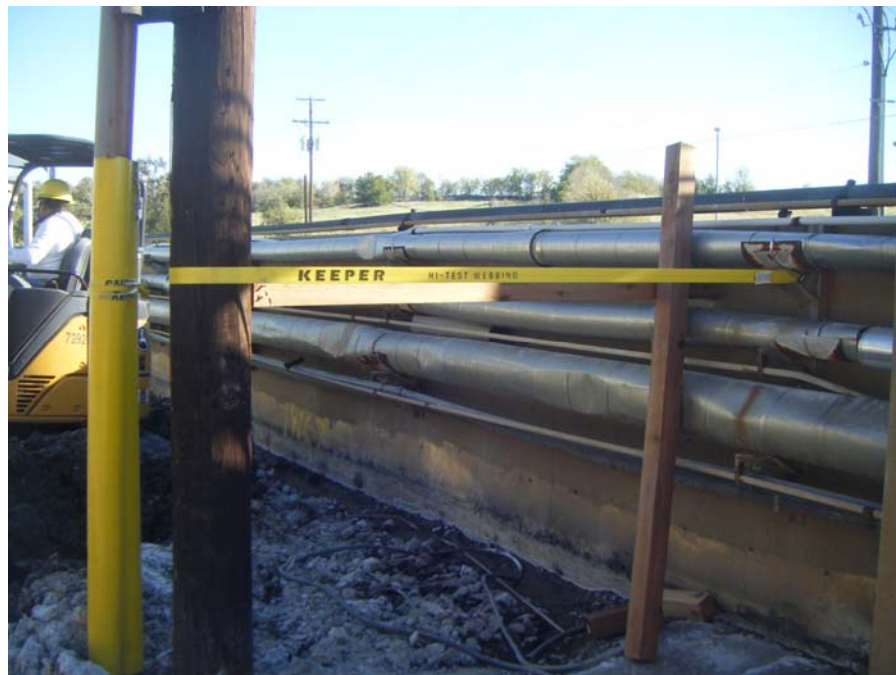
Photo 24: Support for power pole near trench, west end of project.

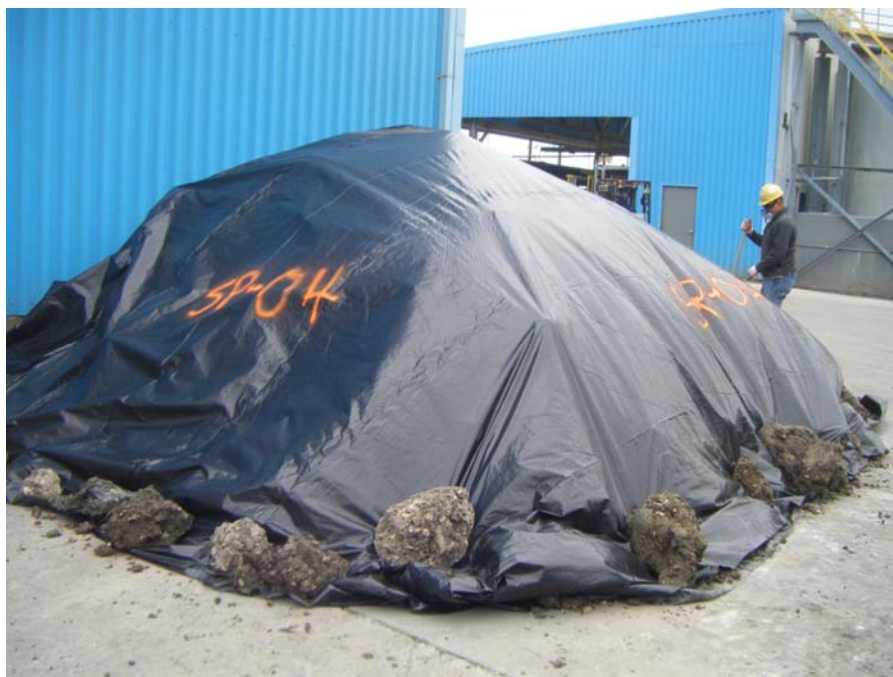
Photo 26: Stockpiled excavated soil prior to off-site disposal

Based upon the waste characterization results, the material was disposed off-Site under manifest to a hazardous or non-hazardous waste landfill. Approximately 258 cubic yards was manifested to Waste management's DFW Landfill in Lewisville, Texas (Permit No. 1025-B) as a Class 2 waste. Approximately 55 cubic yards was determined to be a characteristic waste based upon TCLP data, and was manifested to Chemical Waste Management's hazardous waste disposal facility in Sulphur, Louisiana (EPA ID No. LA0000147272). Manifests for the disposal of all soils from the drain excavation are provided in **Attachment D**.

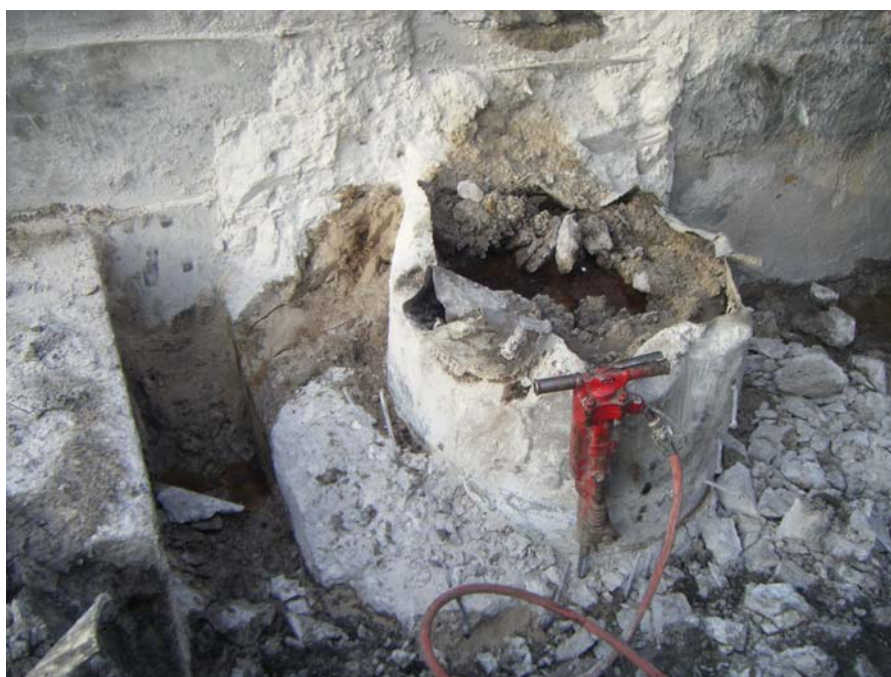
Photo 28: Former sump area, infilled with concrete.

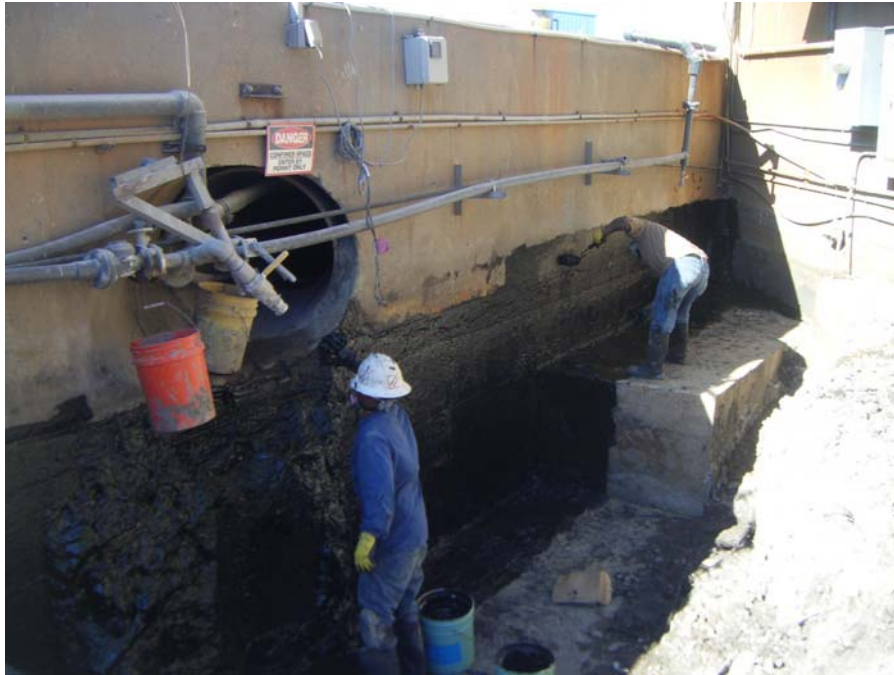
Photo 29: Applying liquid asphaltic membrane at far west end of project.
