APPENDIX 11
MISCELLANEOUS ASSESSMENTS – INTERIM ACTION REPORTS

Date:	May 19, 2014	Project No.:	130-2086
To:	Matt Love	Company:	Exide Technologies
From:	David E. Poe, P.E.		
cc:	File	Email:	
RE:	INSPECTION AND GEOTECHNICAL TESTING OF DISPOSAL AREA FINAL COVERS – EXIDE TECHNOLOGIES, FRISCO, TEXAS

RE: South Disposal Area Cap Repair Report
Exide Frisco Recycling Center
7471 South 5th Street - Frisco, Texas
TCEQ SWR No. 30516, TCEQ Hazardous Waste Permit No. HW-50206; TCEQ
Agreed Order Docket No. 2011-1712-IHW-E; EPA ID No. TXD006451090;
W&M Project No. 112.072

**REPORT ON INTERIM ACTIONS
SLAG AND BATTERY CASE FRAGMENT
REMOVAL AND DISPOSAL**

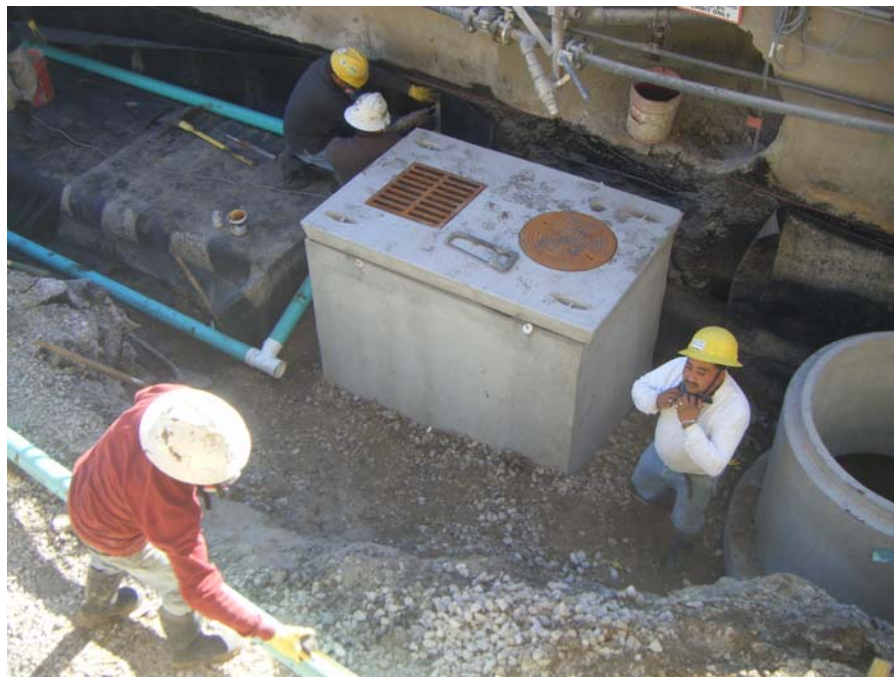
Photo 30: Installation of sump for surface drainage

- Two new collection sumps were constructed at the west end of the wall, one for the new underdrain system, and a second for surface runoff.
- Replacement of the removed concrete, including installation of chemical resistant waterstops.

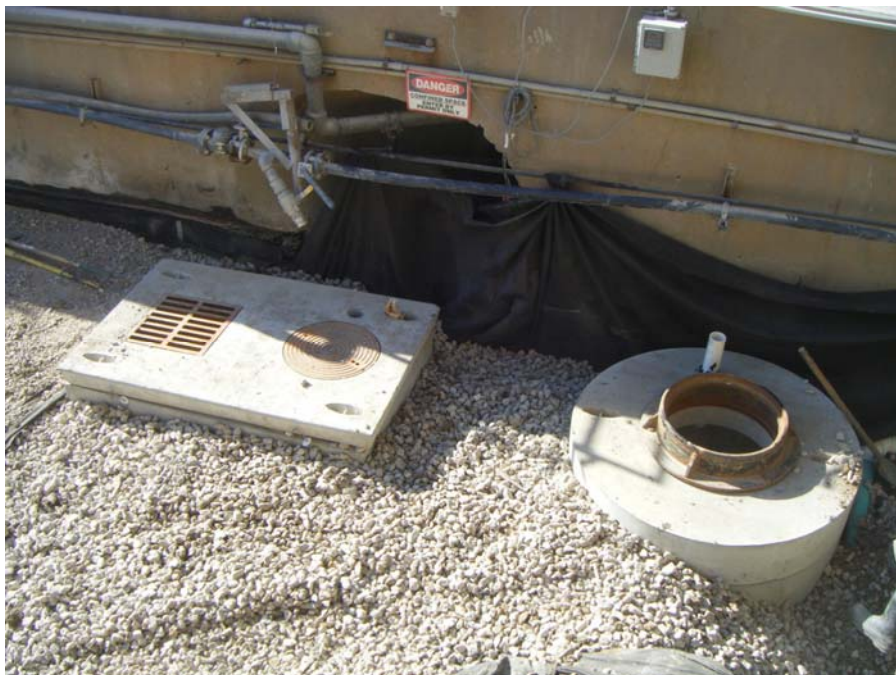
Photo 31: Sump and underdrain manhole after backfilling

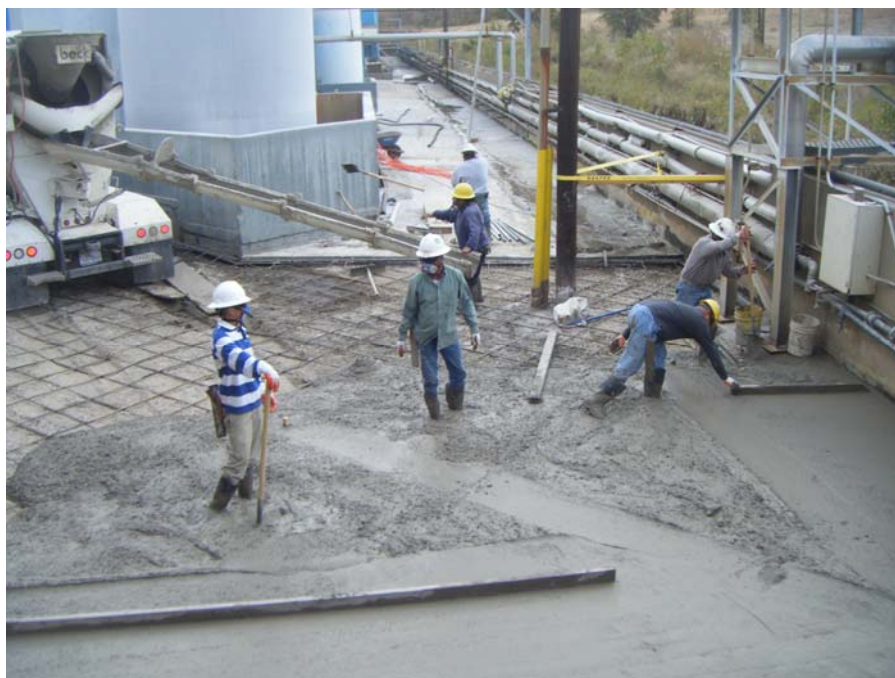
Photo 32: Finishing concrete surfacing at far west end of project.

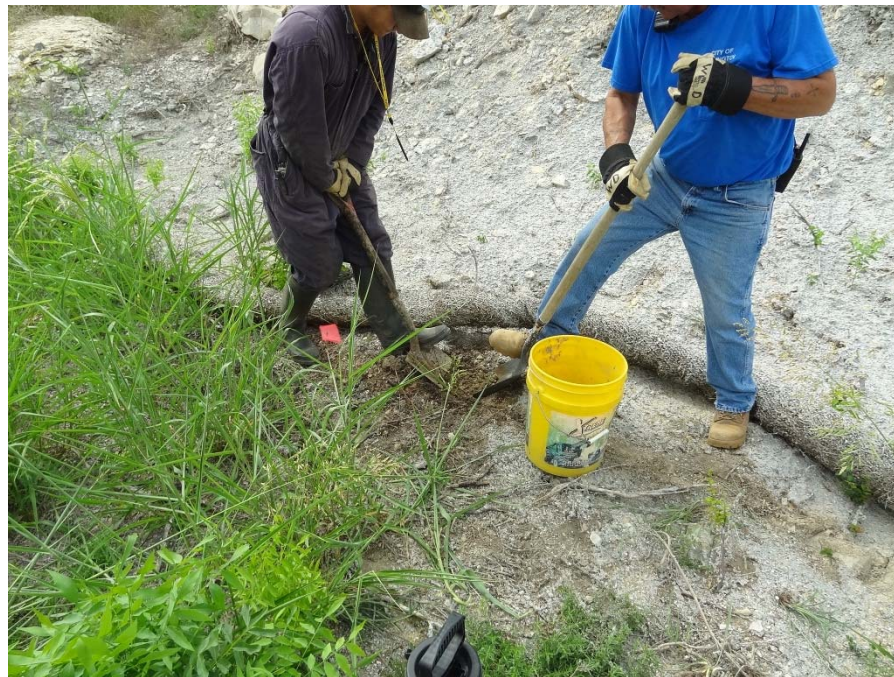
Photo 2: Removal of plastic battery chips near the southern boundary of the SDA.

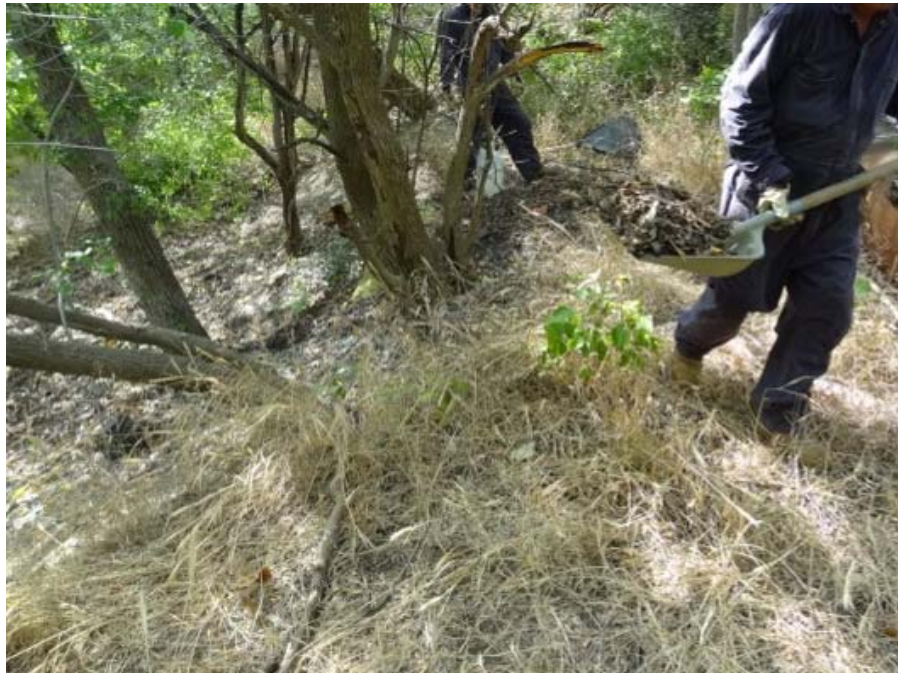
Photo 3: Removal of furnace slag fragments (slag) and plastic battery case fragments (BCFs) from vegetated area south of the SDA.

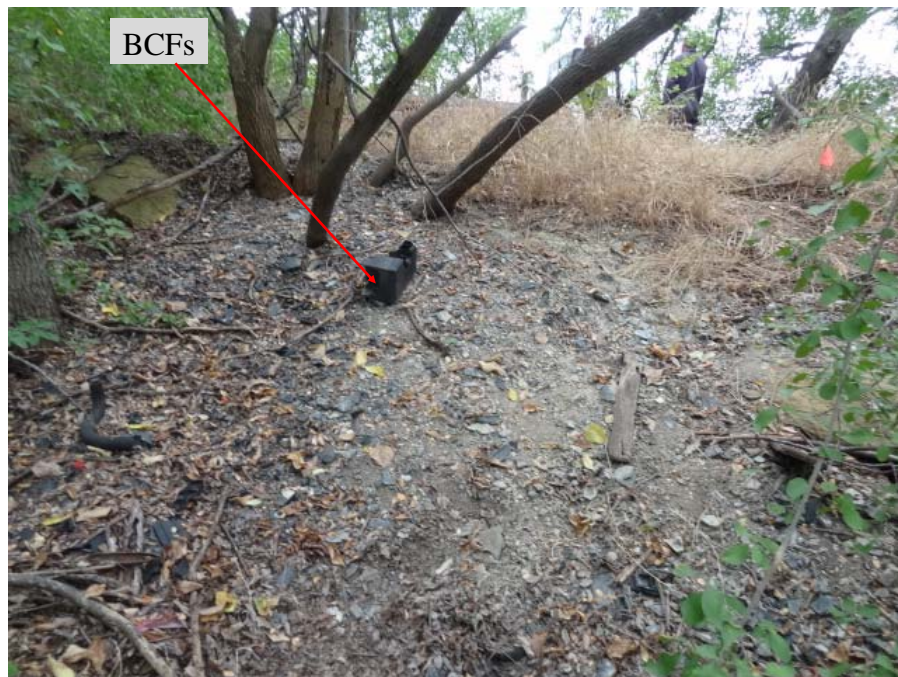
Photo 4: Debris field of BCFs in densely vegetated area east of the SDA.

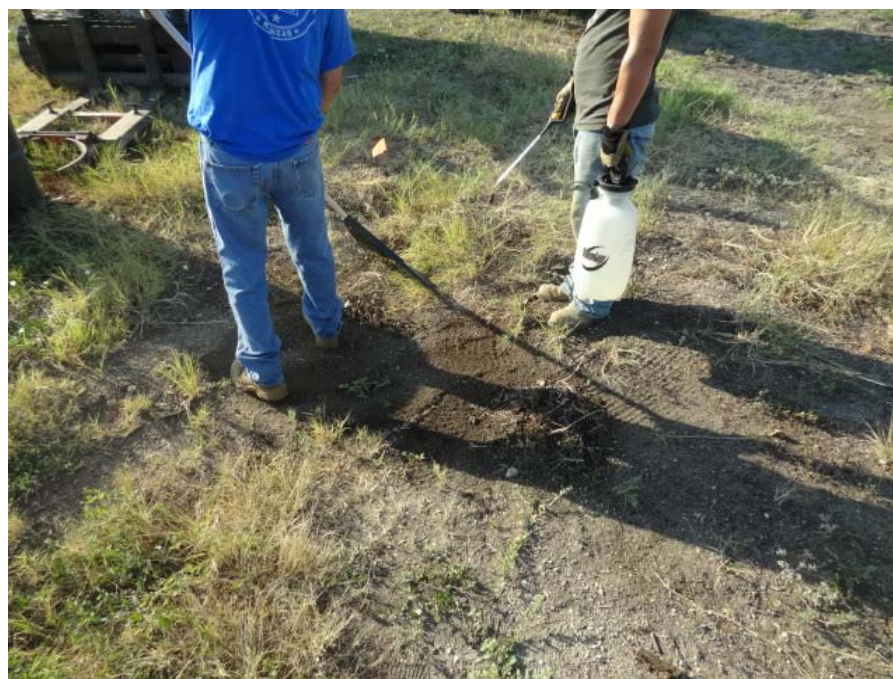
Photo 6: Raking up debris field of BCFs and slag in central portion of the NDA.

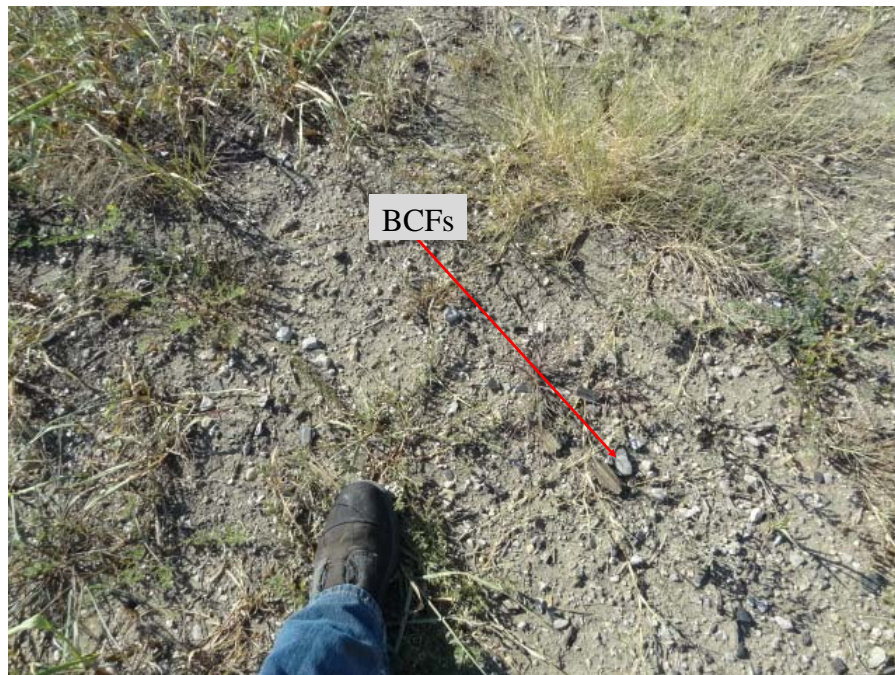
Photo 7: Typical BCFs scattered across exposed soil in the NDA.

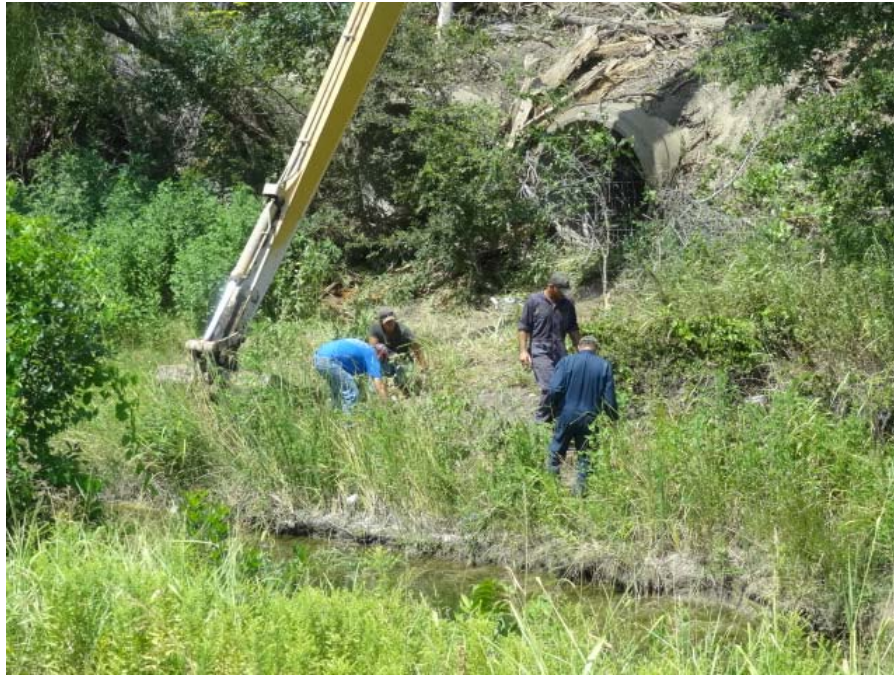
Photo 9: Slag removal along the north bank of Stewart Creek.

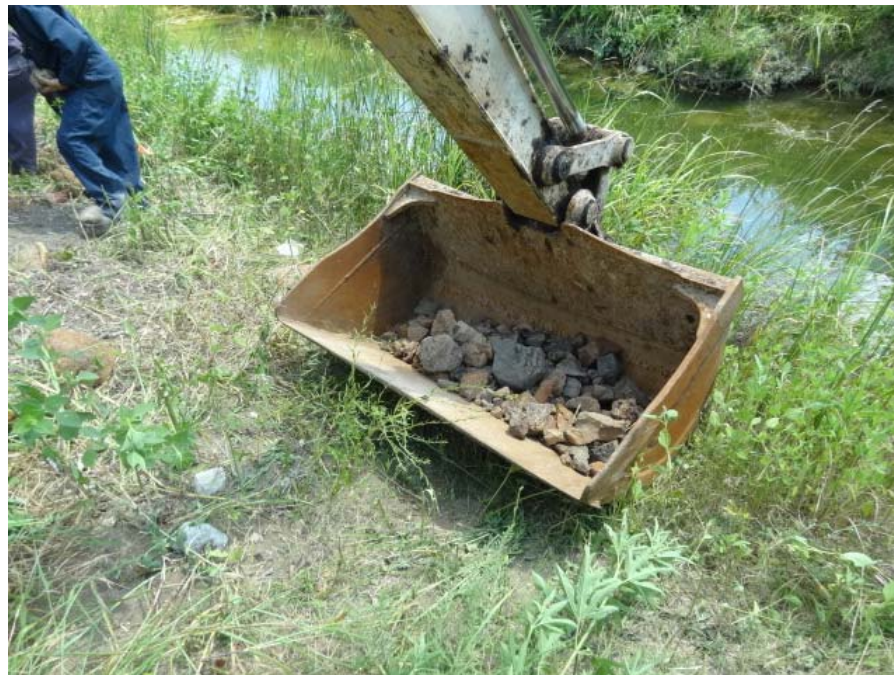
Photo 10: Excavation bucket being used only for transportation of slag hand removed slag.

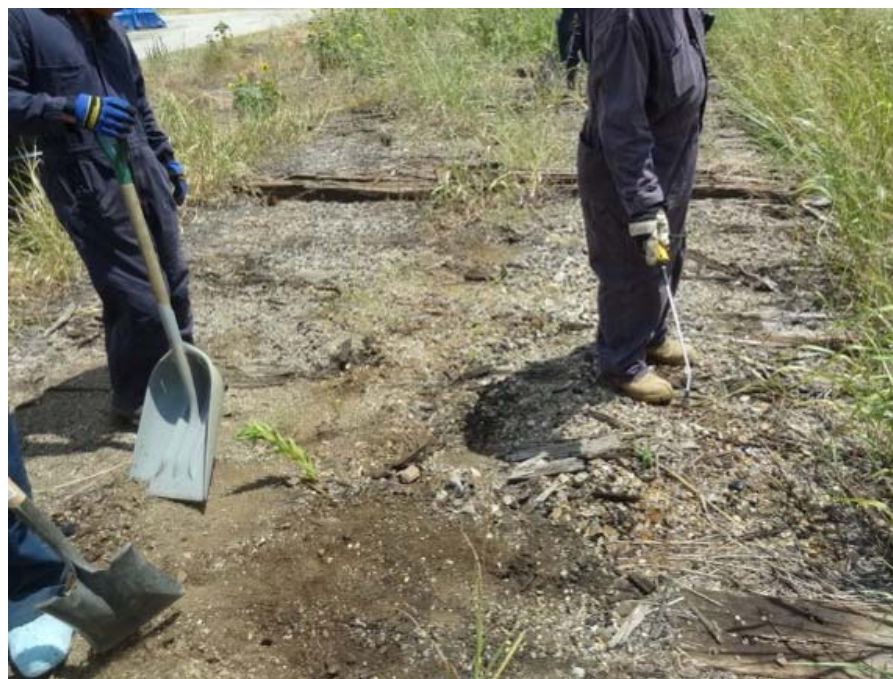
Photo 12: Water misting soil in removal area to eliminate airborne particulates.

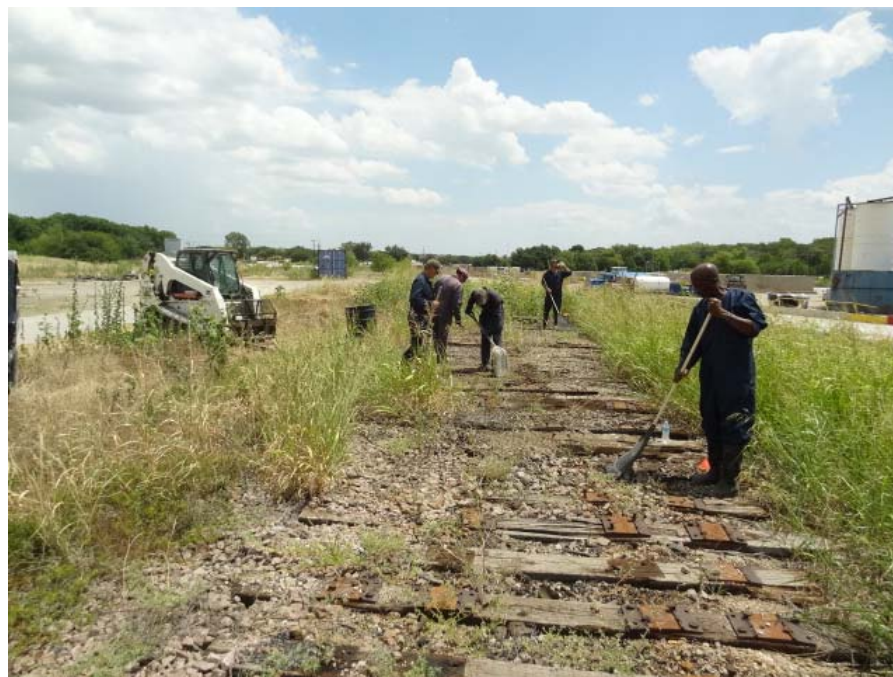
Photo 14: Cleanup of slag and BCFs along the railroad spur in the NDA.

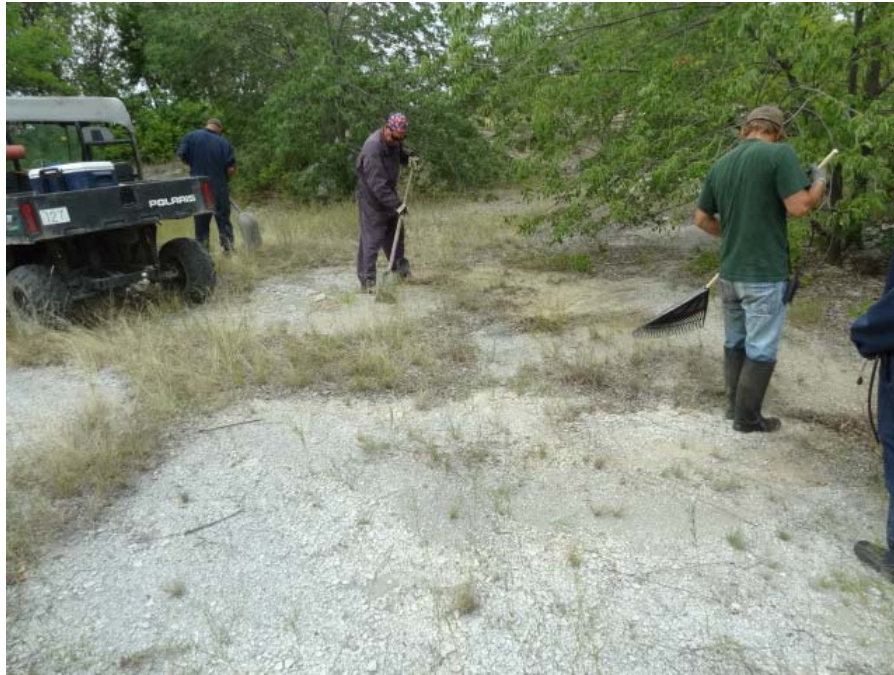
Photo 15: Clean up of large debris field south of the SDA boundary.

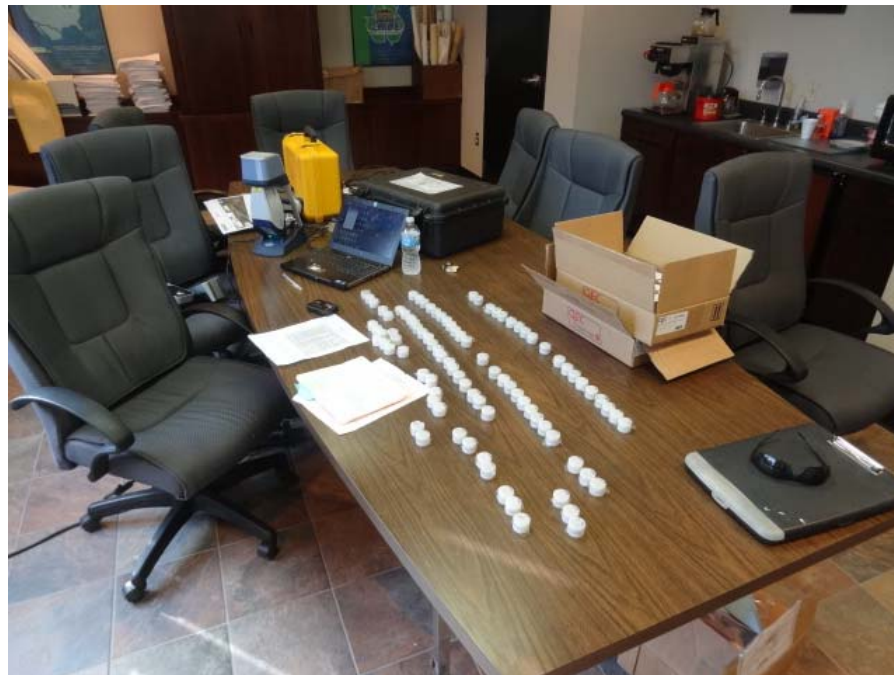
Photo 16: Scanning samples with an X-ray fluorescence system (XRF).
